Oregon Paper Mill Repairs Damaged Chipper Disk With CeramAlloy... Savings Could Top \$100,000!

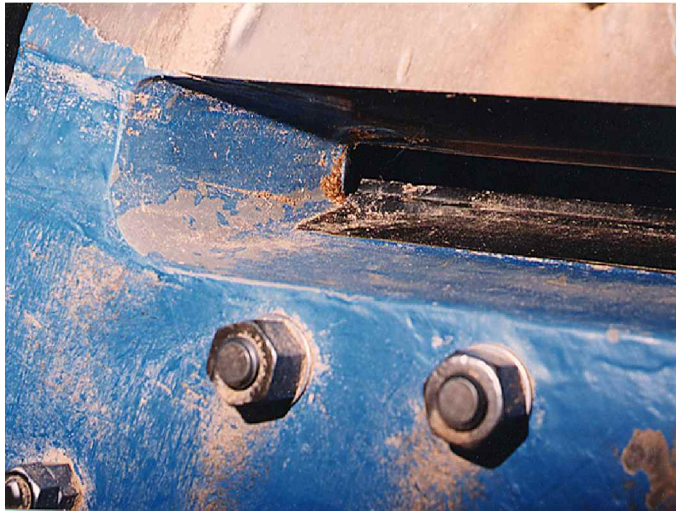
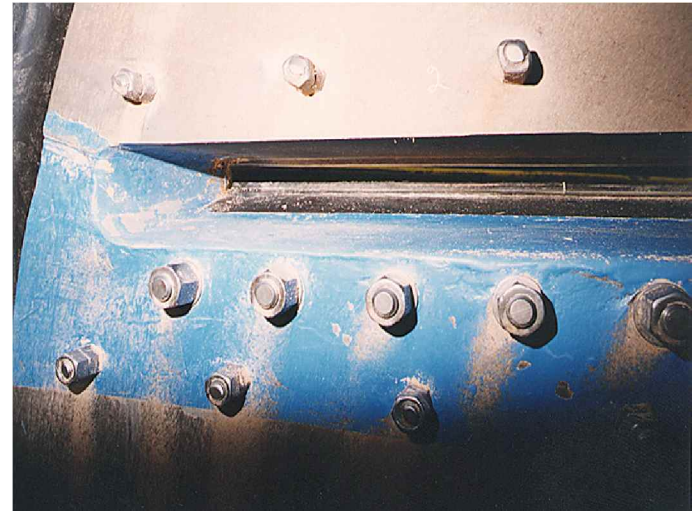
One year after repairs were made to all 8 pockets of a large (150+ inch diameter) chipper anvil, the enclosed photos were taken. The repairs involved rebuilding badly worn areas, which, if allowed to progress, would have threatened the structural integrity of the wheel. Replacement would have cost up to \$100,000 plus even more costly downtime

pocket had been eroded by about 2 inches, the shelf by $\frac{3}{4}$ inch, and the face by up to $\frac{1}{2}$ inch. Two kilograms of CeramAlloy CP+ were used to rebuild each pocket, followed by an overlay of CeramAlloy CL+ to protect the first eight inches of the face. Material costs were less than \$3,500, and labor consisted of two plant people, plus the ENECON Field Engineer, for 1-

In the pictures, wood residue shows as discoloration, especially on the face. The CL+ in those areas is virtually unaffected. The knives are changed daily by loosening the top two rows of studs with an impact wrench. The wrench has chipped pieces out of the face, but these do not progress beyond

the initial damage, and are not considered significant. Incidentally, the erosion is so severe that the steel nuts are worn round and must be replaced frequently!
