U.S. Navy Salvages Main Salt Water Circulating Pump on an Amphibious Assault Ship with CeramAlloy

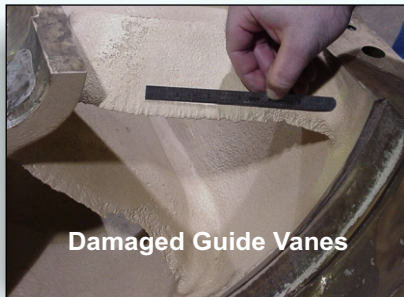
Damaged Guide Vanes

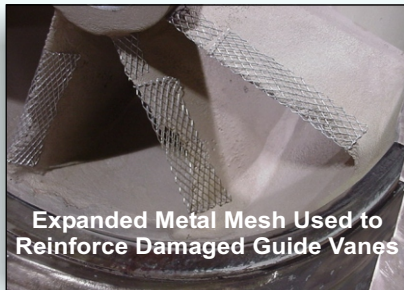
Expanded Metal Mesh Used to Reinforce Damaged Guide Vanes

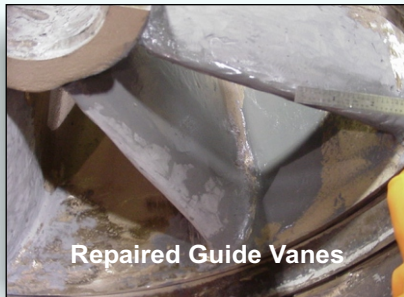
Repaired Guide Vanes

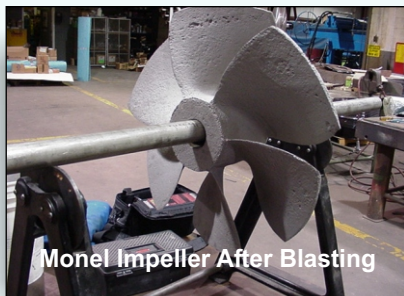
Monel Impeller After Blasting

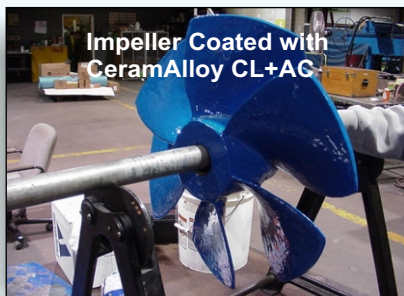
Impeller Coated with CeramAlloy CL+AG

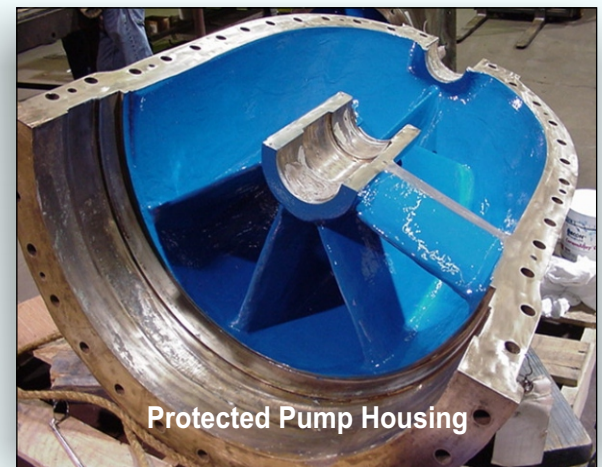
Protected Pump Housing
