Client: Waste water treatment plant.
Location: Northeastern U.S.
Problem: Corroded & leaking main influent pipe.
Solution: Repair leaks with *DurAlloy*; reclaim pipe with *DuraWrap Carbon Fiber Pipe Wrap System*.
Cost: \$40,000 total turn-key project.
Savings: \$100,000+ replacement cost.

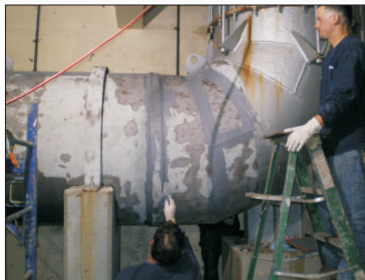
After grit blasting, leaks repaired with DurAlloy.

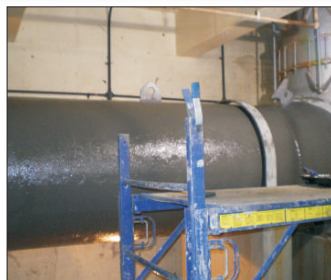
DuraWrap Primer applied.

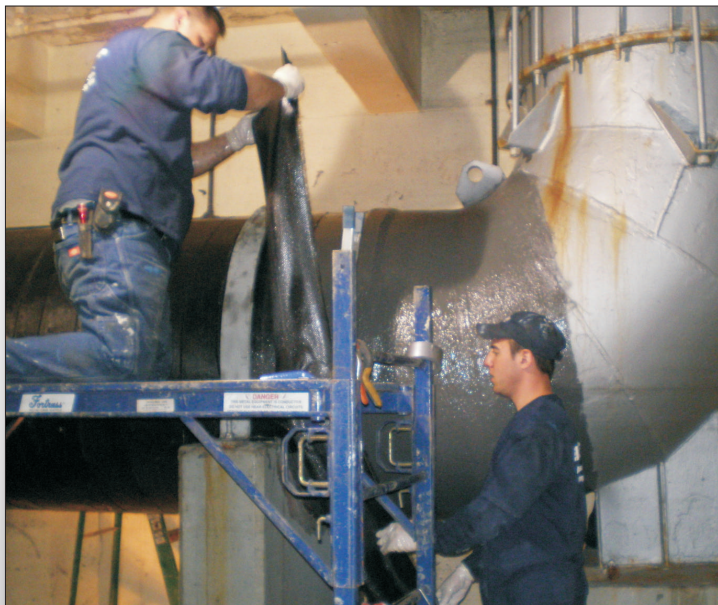
DuraWrap Carbon Fiber, impregnated with DuraWrap Polymers, being wrapped around pipe section.

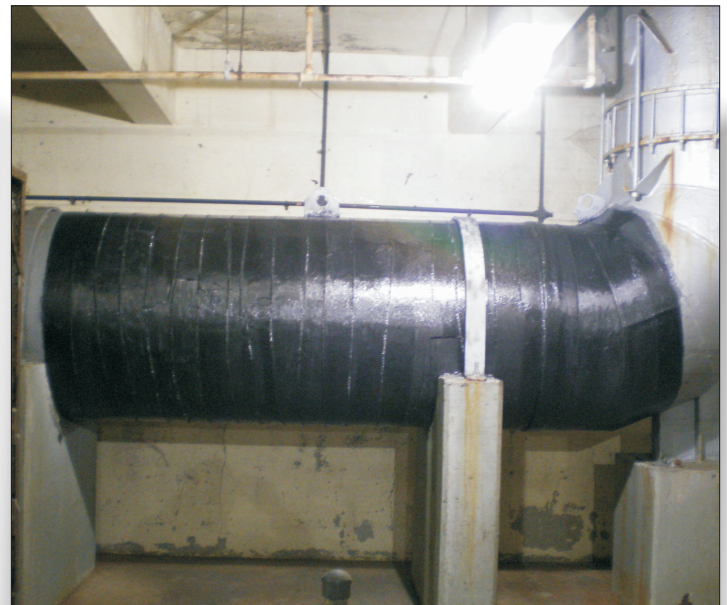
Completed DuraWrap System.
