Oil Company in Thailand Repairs 22 'Problem Areas' with DuraWrap

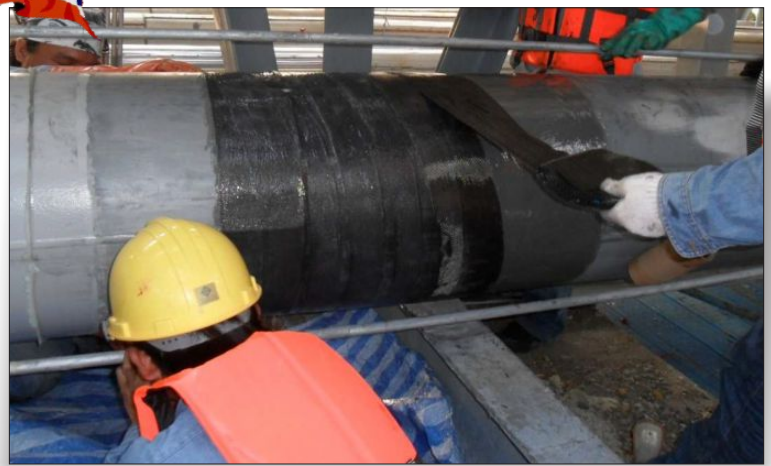
Before

Problem: 20" diameter pipe was severely rusting in 22 different locations.

Solution: Original galvanized coating was removed. Rusted areas were manually prepared by grinding and wire brushing. *DurAlloy* was used to repair any damaged areas on the pipe. *DuraWrap Primer* was applied followed by two layers of *DuraWrap Carbon Fiber System*.
