METALCLAD DurAlloy Repairs Main Propulsion Shaft On MSC Vessel

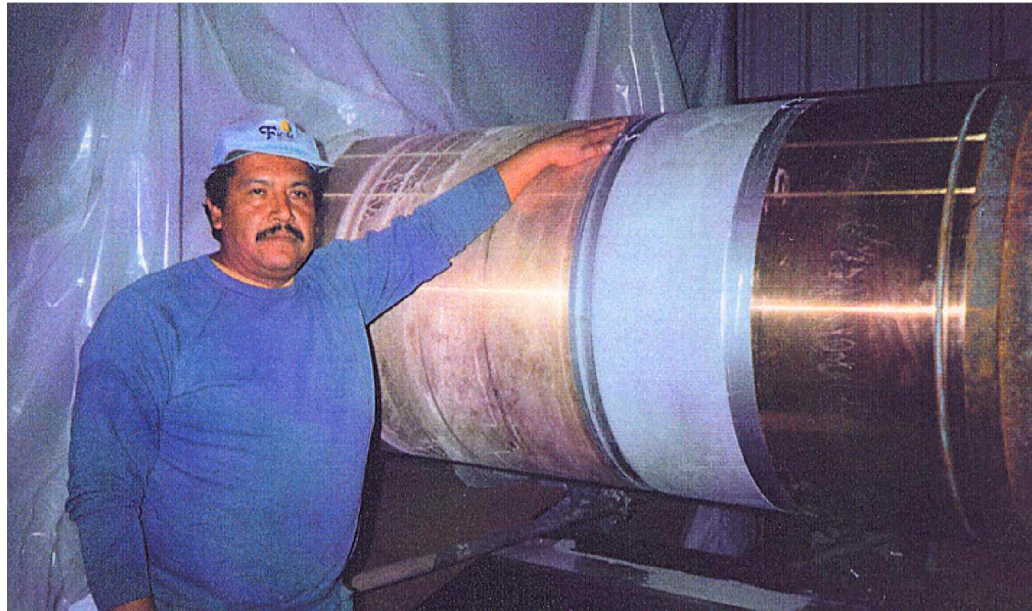
Following a Tuesday presentation to discuss potential repairs using ENECON High Performance Polymer Systems, ENECON representatives received a call on Thursday to come in and advise on a possible shaft repair. Of course, this main propulsion shaft from a Military Sealift Command (MSC) vessel happened to be **50 feet long, 31 inches in diameter and weighed in at 50 tons!!** An initial repair, which had been performed with conventional fiberglass

materials, was deemed unacceptable after machining due to excessive pitting and poor adhesion. As a matter of fact, the shaft was never even taken off the lathe.

After removing the fiberglass, the shaft was heated and washed down repeatedly to leach out any residual contaminants until the substrate was completely clean. The area was threaded and strips of 1/8 inch rubber were bonded around the

shaft at the edges of the area to be repaired. **METALCLAD DurAlloy** was applied to the area and, using an aluminum straight edge fabricated in the shop for the task at hand, the section was uniformly overbuilt to the height of the rubber strips.

Once solidified, the DurAlloy was machined back to the required tolerances and the repair was inspected and accepted by the surveyor.
