Power Plant In The Philippines Chooses CHEMCLAD & CeramAlloy To Repair & Protect Critical FGD Pipeline

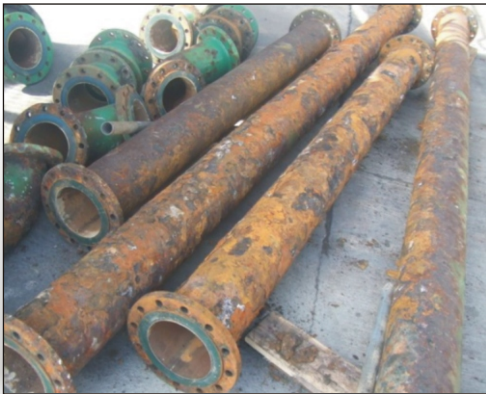
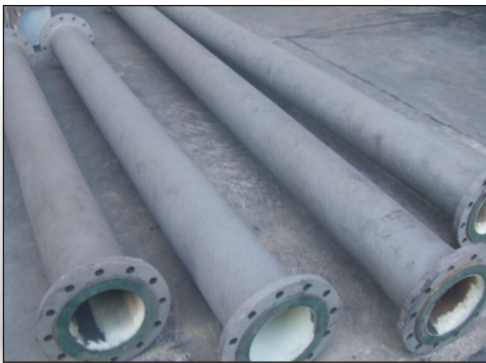
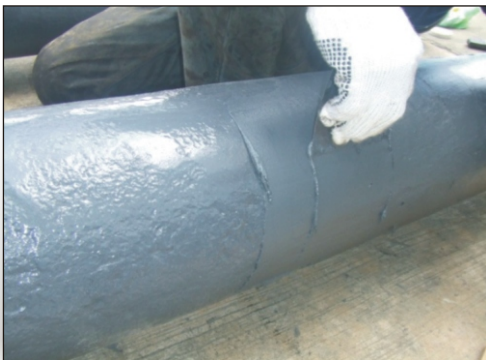
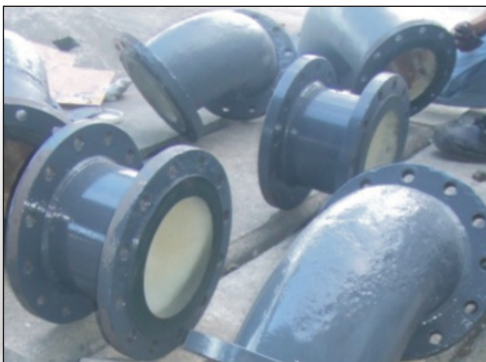
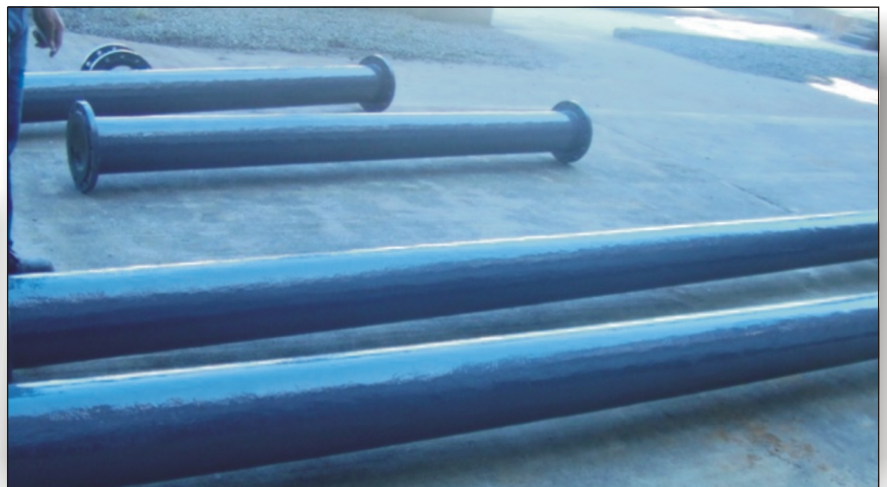
The make-up pipeline for the Flue Gas Desulfurization (FGD) section of this power plant in the Philippines was severely damaged by corrosion.

All components were first thoroughly prepared by grit blasting. An initial coat of CHEMCLAD SC was then applied to all surfaces.

CeramAlloy CP+[AC] was then applied to rebuild all the deeply pitted areas, followed by a final coat of CHEMCLAD SC to complete the application.
