## FLEXICLAD ER<sup>®</sup> Repairs Rubber Covered Drive Shaft at Wastewater Treatment Facility

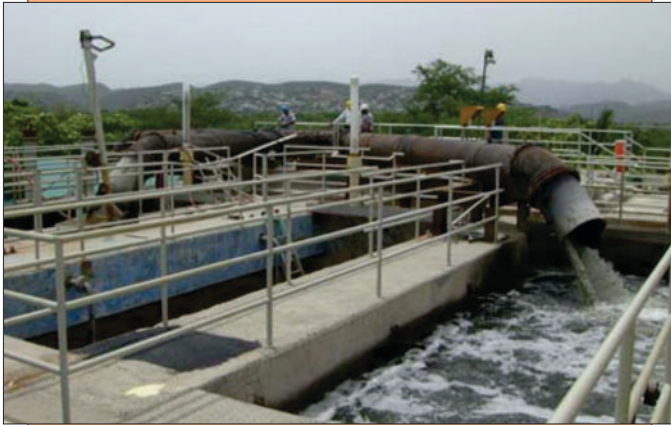
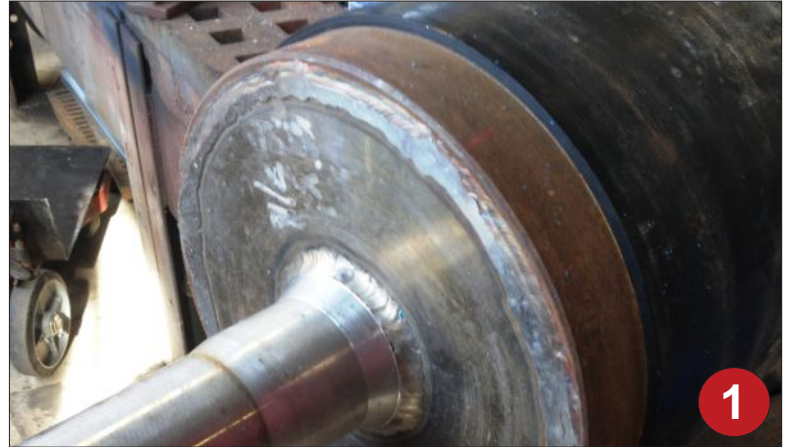
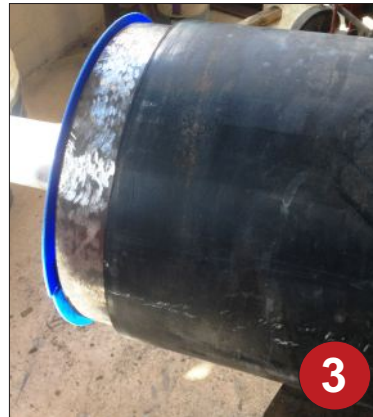
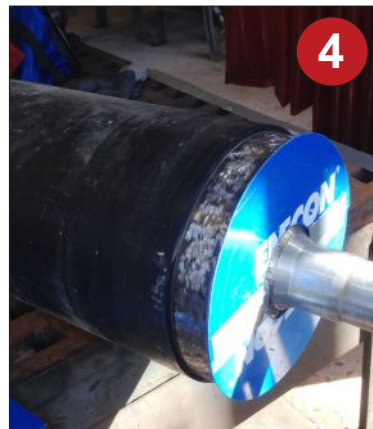
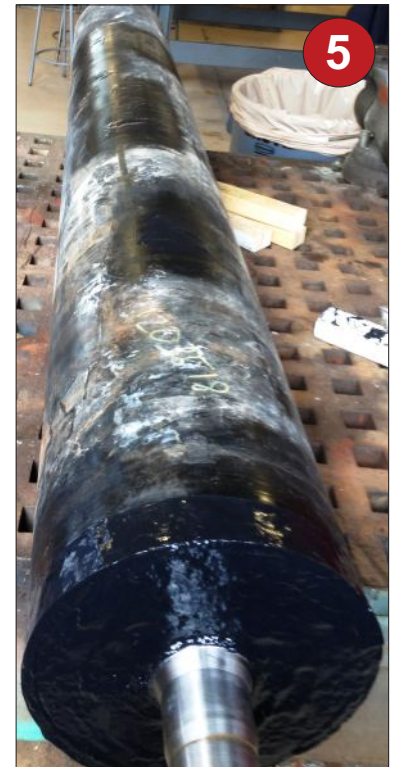
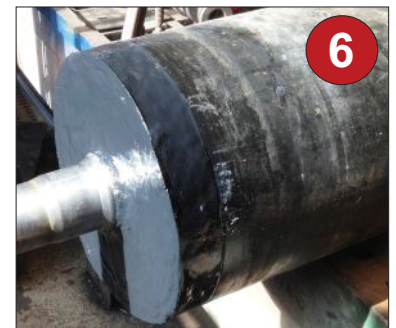
The end of this 10 inch diameter drive shaft, used on the belt system for de-watering the 'floc' at this wastewater treatment facility, had to undergo some welding repairs. The existing rubber shaft covering had to be cut back to allow for the welding process.

The plant engineers needed to get the system running so they turned to their local ENECON Field Engineering Specialist for help. He suggested using FLEXICLAD ER to rebuild the exposed end – providing a seamless rubber finish on the shaft.

A plastic former was created (an ENECON mixing board was used for this) to help in the rebuilding process. After grinding the metal, a ¼ inch layer of FLEXICLAD ER was applied to re-finish the shaft end. After 30 minutes, the former was removed and more FLEXICLAD ER was applied to complete the repair on the exposed end of the shaft.

This entire project was successfully completed in just one day saving the plant thousands of dollars in down-time associated with conventional rubber repairs which would have taken 3+ weeks.
