Tugboat Operator Selects CeramAlloy to Combat Erosion/Corrosion on Their Kort Nozzles

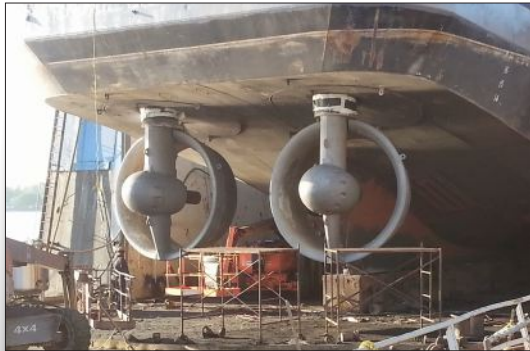
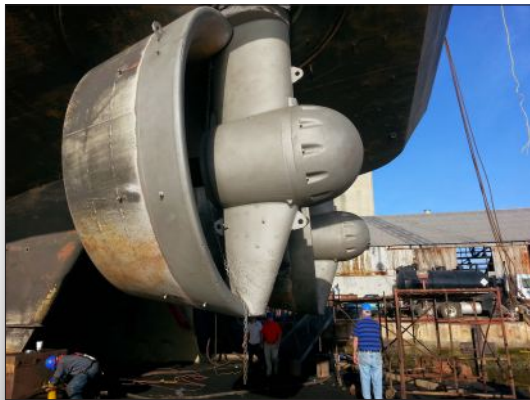
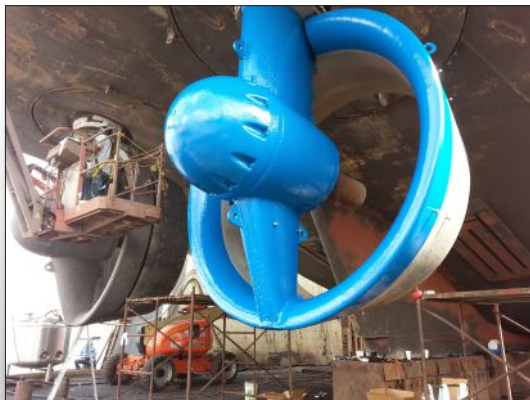
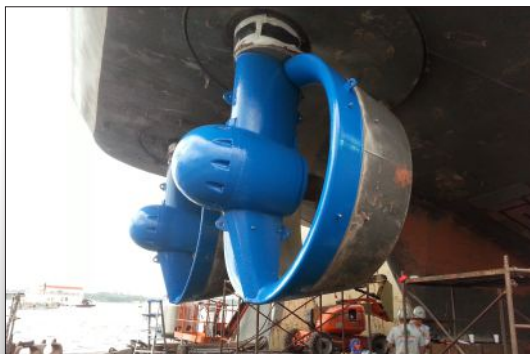
This tugboat belonging to a major international marine company in Florida was suffering from the effects of erosion & corrosion on its Kort nozzles. The local ENECON Fluid Flow Systems Specialist was called in to help find a solution.

After preparing the surface by grit blasting to acquire a 'white metal' finish, two coats of CeramAlloy CL+AC were applied.
