CHEMCLAD SC & DurAlloy Solve Corrosion Problems at Indonesian Plant

The local ENECON Dealer located in North Sumatera Island in Indonesia was asked to provide a commercially proven, cost effective solution for this condenser pump repair and protection project at a state owned power station.

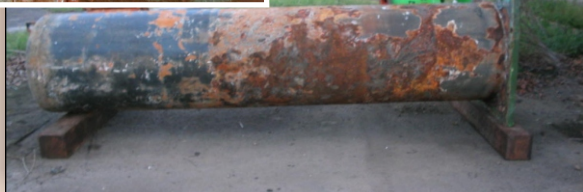
Note the blistering & under-film corrosion of the conventional epoxy paint system

The existing epoxy coating had failed badly and under-film corrosion was destroying the spool

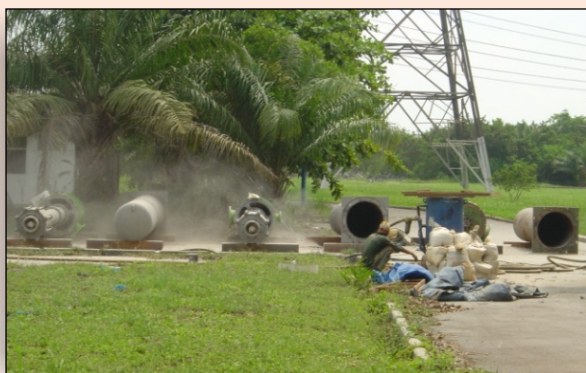
All pump sections were grit blasted.

The repair procedure included thorough grit blasting of the metal. All deeply pitted and damaged areas were then re-built with METALCLAD DurAlloy and sanded smooth.

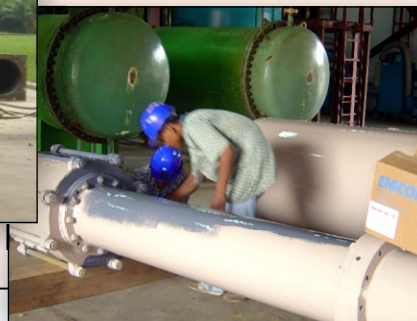
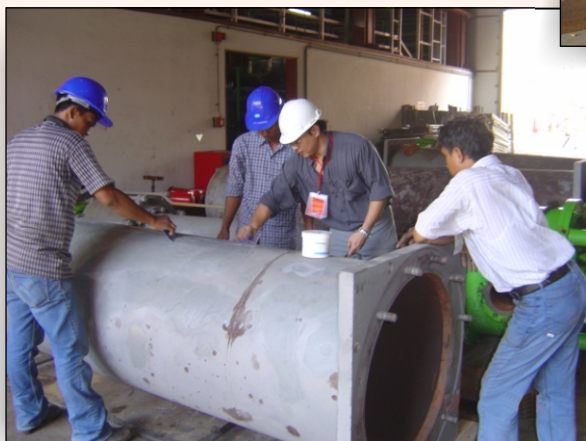
DurAlloy being applied to repair pitted areas.

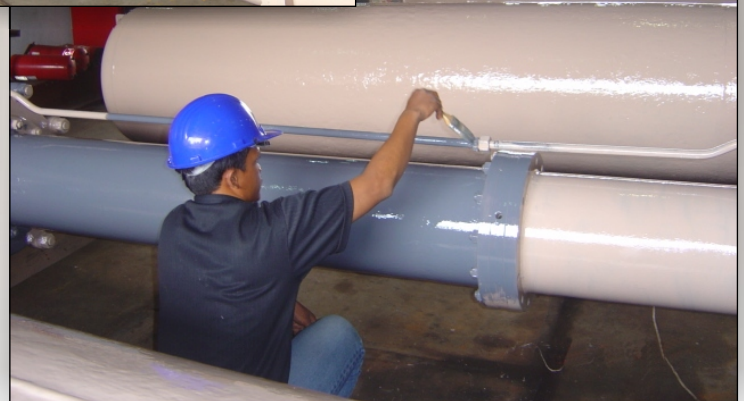
Final coat of CHEMCLAD SC being applied.

Two coats of CHEMCLAD SC were then applied to provide long-term protection to these pump sections.
