## Major Florida Utility Company Solves Recurring Concrete Problems with ENECRETE DuraFill & DuraQuartz

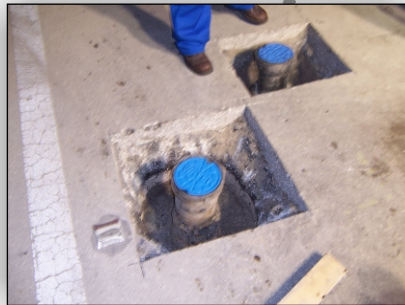
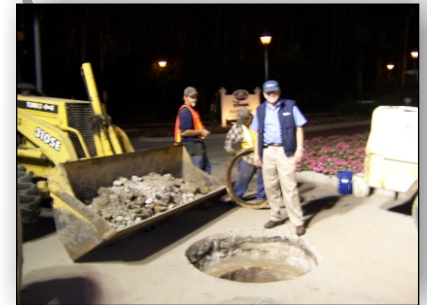
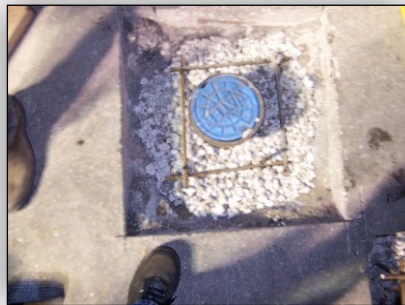
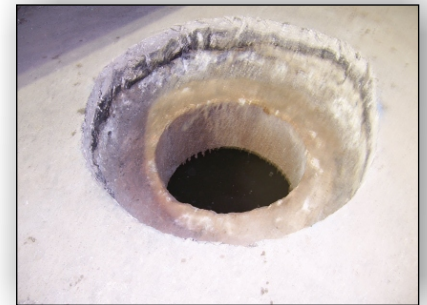
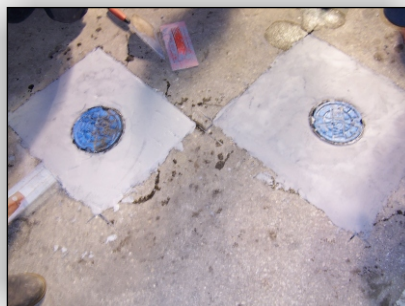
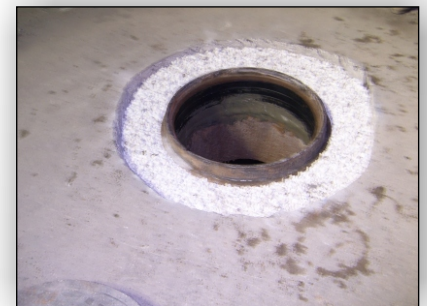
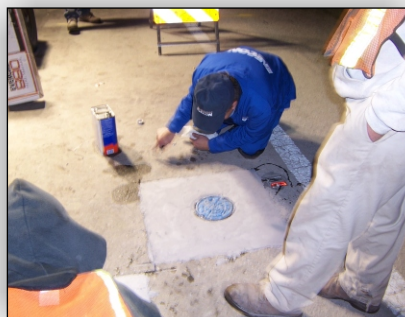
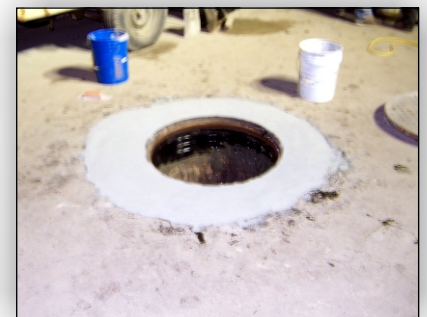
The utility purchased a few skid-loads of these materials in order to complete a number of such repair projects. These pictures illustrate just a few of them.

The Utility Engineers turned to their local ENECON Field Engineering Team who recommended our ENECRETE systems for these applications. **DuraFill** mixed with locally acquired large aggregates was first utilized to fill in the deep holes and then **DuraQuartz** was used to top-off the repair (about ½ thick) to provide for an extraordinarily durable road surface.
