## Polish Water Treatment Plant Solves Concrete Waterproofing Problems with ENECRETE WP & WS

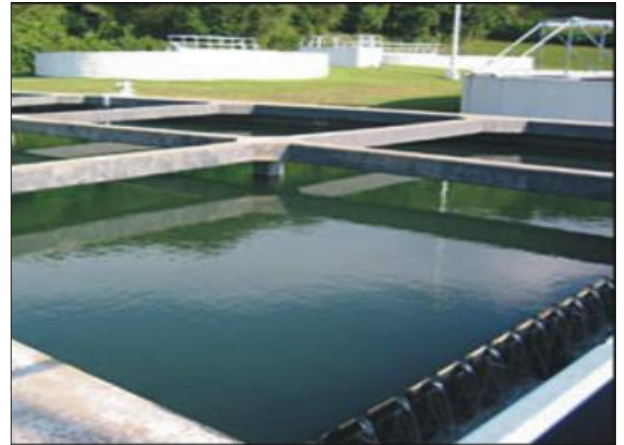
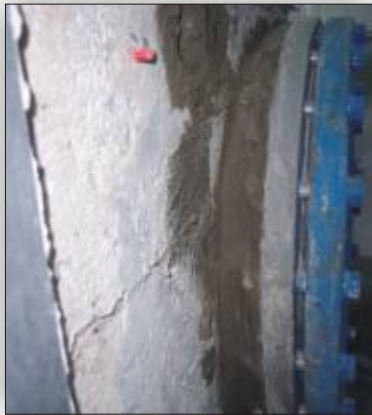
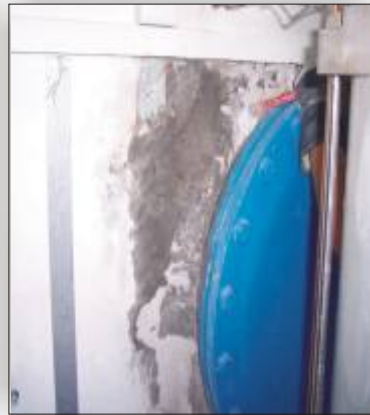
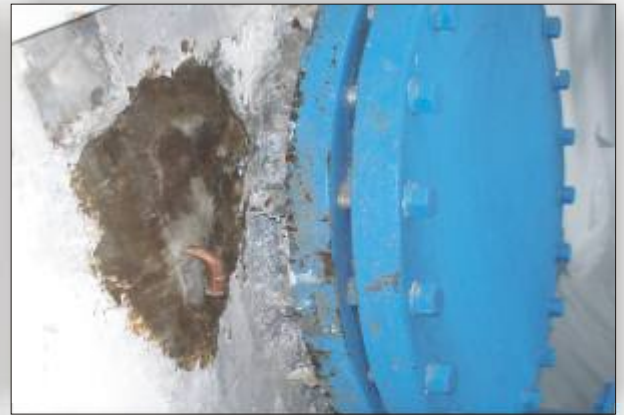
“These pictures are from a water treatment facility. There was a problem with a concrete tank used for water conditioning / purifying. This tank contains sand which helps to clean the water. After a number of years, the tank was no longer waterproof. There were many leaks, especially near the pipes that go through the tank. Our client tried to solve this

problem many times but nothing helped. We tried to help and we succeeded.

We thoroughly cleaned the surface of the wall and the pipe, dried it out and then applied SuperBond to the metal pipe. We then filled the space between the pipe and the wall (about 4 cm wide and 8 cm deep) with WP and then applied a trowelable layer of WS to smooth it out and make it look nice. All the leaks in the concrete wall were

sealed with WP and then followed by 2 coats of WS to seal the porous cement.

Everything looks nice and it really works. We are now looking at other repairs on this tank which is about 20 meters long x 20 meters wide x 10 meters high.”
