## ENESEAL Solves Leak & Corrosion Problems for Property Management Group

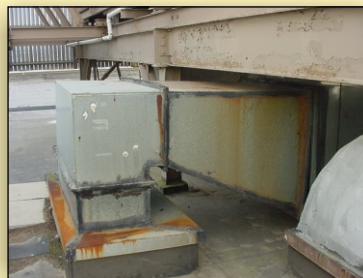
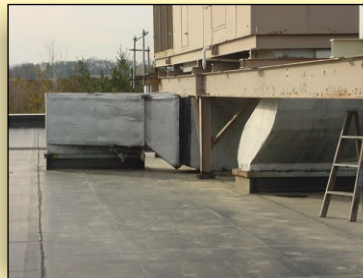
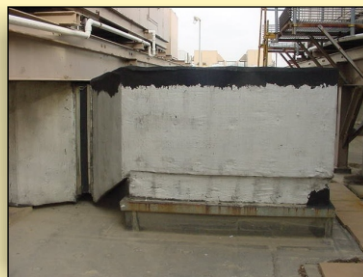
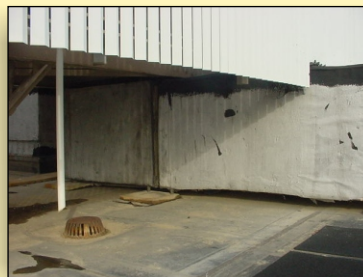
**Before...**

These air ducts, located on a roof of a building belonging to a local utility on Long Island, NY, had developed numerous leaks over the years. The property management group of the utility company was also concerned with the condition of the steel under the duct's insulation.

The ENECON North East Engineering Team was called in and they recommended a standard ENESEAL HR installation to...

- ▶make the ductwork water-tight;
- ▶provide for a heat refractive, energy efficient, breathable 'skin' over the insulation;
- ▶provide an aesthetically pleasing view of the ductwork from the busy street below.

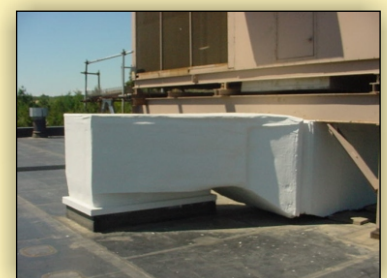
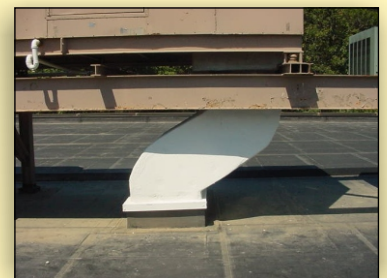
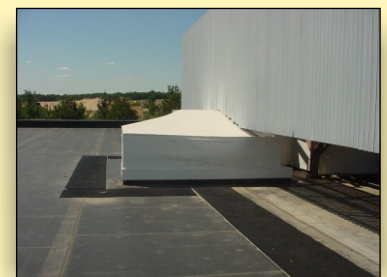
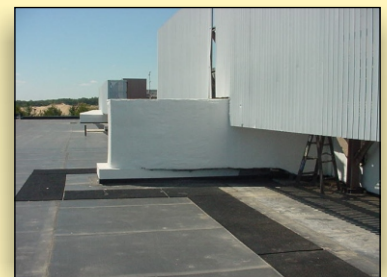
**After...**

These 'before' and 'after' pictures speak to the success of this installation.
