## ENESEAL HR Solves Leaking Hangar Problems at Indian Airport

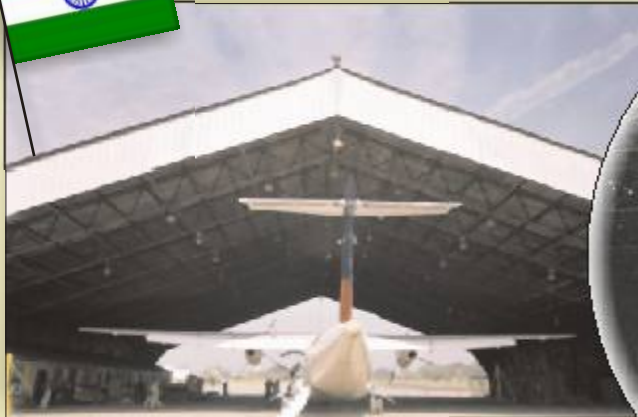
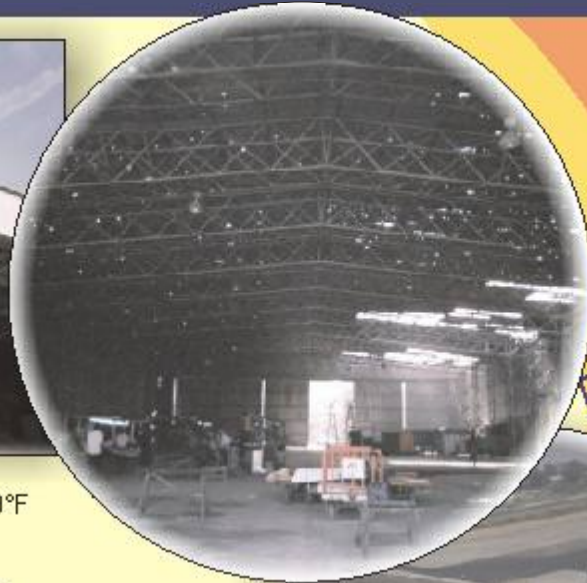
Before

Engineers at the airport in Calcutta were tired of “seeing stars” through the roof of some of their airplane hangars. Conventional tar-felting could not provide the long-term repair solution they were looking for on these corrugated metal roofs. Each hangar is over 32,000 square feet.

All roof surfaces were cleaned and a rust “converter” was used to treat rusted areas. Fiberglass reinforcing mesh was used to bridge holes in the roof with ENESEAL. Two additional coats of ENESEAL HR were then applied to completely seal the entire roof area. The project was completed in about 80 days – well ahead of the stipulated 90 day schedule.

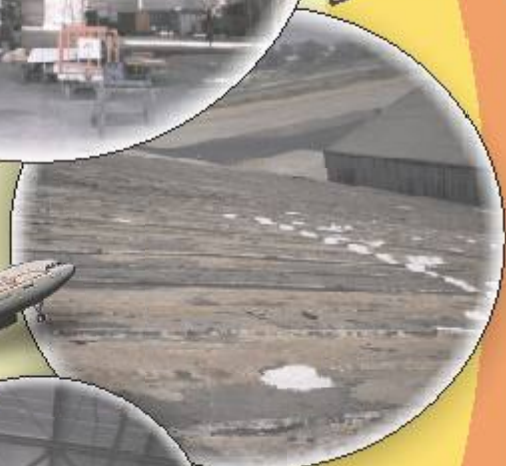
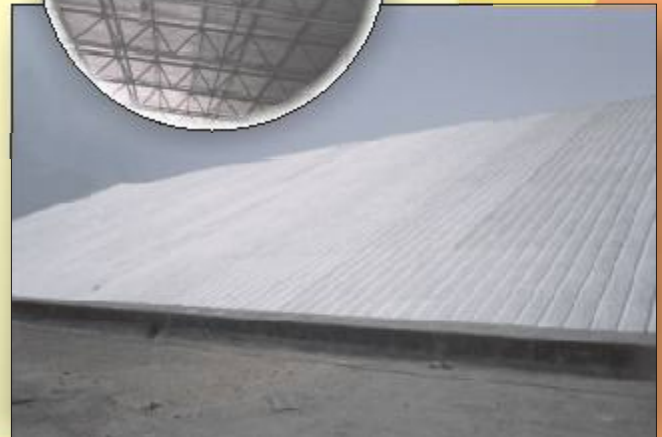
After

Just two days after the application was finished, torrential rains buffeted the city. To the amazement of the airport engineers, the ENESEAL coated roofs were completely water-tight. They are now in the process of tackling other problem roof areas at the airport.
