## ENESEAL HR Protects Apartment Building Roof In Poland

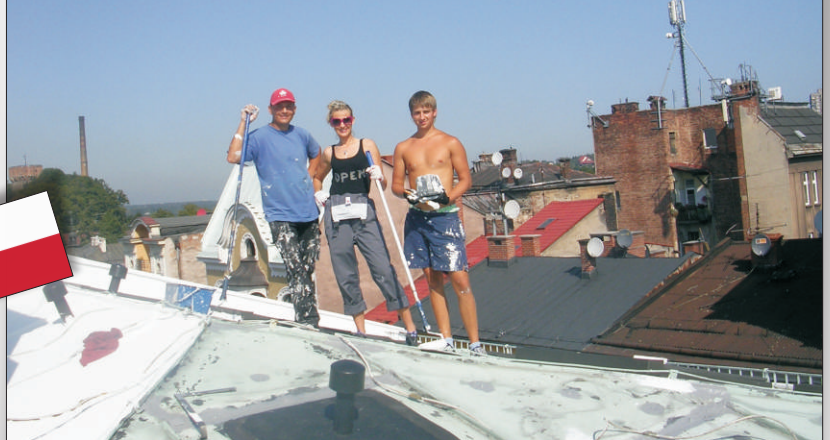
This apartment building's painted galvanized plate roof was leaking and also became very hot in the summer months making the top floor apartments uncomfortably warm.

First, all the leaking seams were repaired and sealed with **SuperBond**, **ENESEAL HR** and reinforcement cloth. Then the entire galvanized plate roof was coated with **SuperBond** and two coats of **ENESEAL HR** to provide long-term protection to the roof as well as a heat refractive surface, significantly lowering the temperature of the top floor apartments.
