MILESTONE RESULTS FROM THE NEW A/V

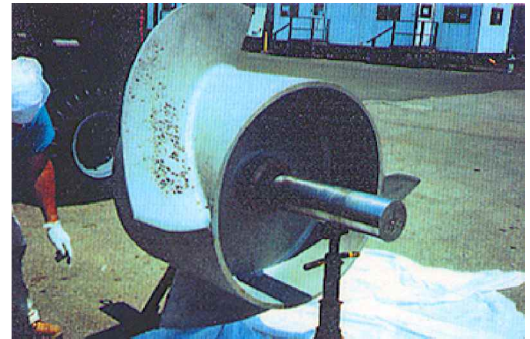
The pump impeller, after grit blasting.

The repair was scheduled for the following Sunday. After grit blasting first on Saturday and again on Sunday morning, the repair was carried out by initially rebuilding the deeply eroded areas with CeramAlloy CP+. This was followed by the

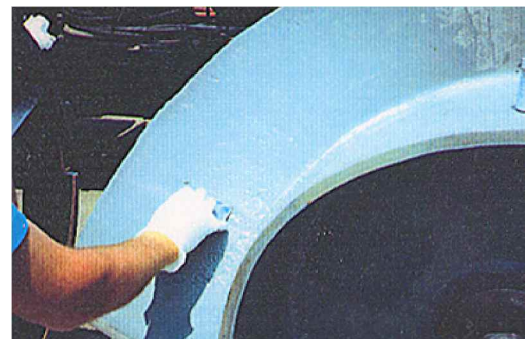
Rebuilding with CeramAlloy CP+

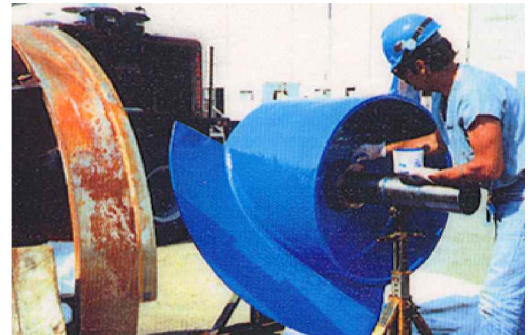
Putting the finishing touches on the impeller.

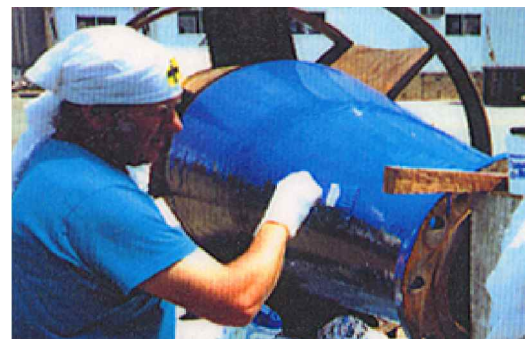
Applying CL+ to one of the diffuser components.

application of two coats of CeramAlloy CL+ to completely protect the components.
