Sea Water Ravages...

CeramAlloy Salvages

Shipboard Evaporator

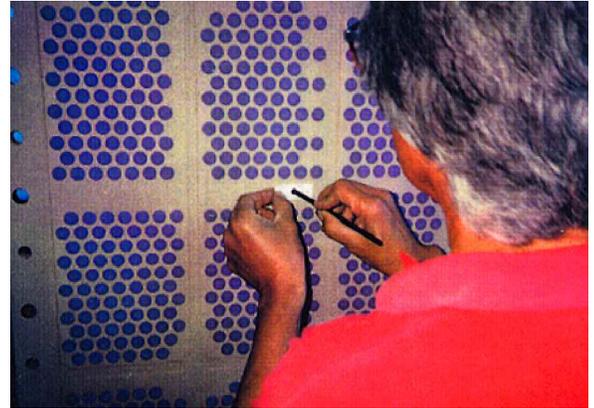
This evaporator from the Military Sealift Command vessel San Jose was found corroded and severely eroded - especially in the areas where the division bars joined the face of the tube sheet. The force of the rushing water actually forces these joints slightly apart, resulting in "water jetting" and increased erosion.

After thorough preparation, which included checking for residual salt contamination and exact measurement

of the "blast profile" (see top photo), CeramAlloy CP+ was first used to rebuild the deeply damaged areas, followed by the application of the CeramAlloy CL+.

"Imageneering" is often what makes a great application even better. In this case, the ENECON Engineer suggested the use of the DuraTough DP to create a perfectly formed and slightly compressible joint at each division bar/ tube sheet mating surface.

In this way, when the pressure of the flowing water force the end cover back, the DuraTough will "fill the void" and eliminate the adverse effects of the accelerated erosion due to water jetting.
