## CeramAlloy Gives New Life to Extinct Valve

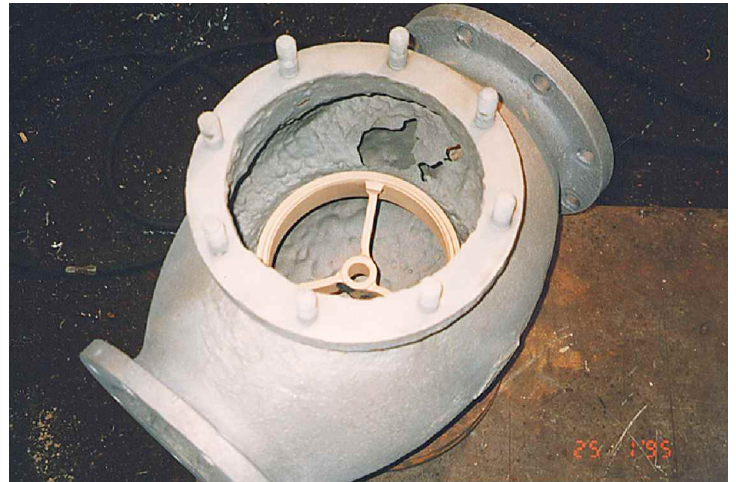
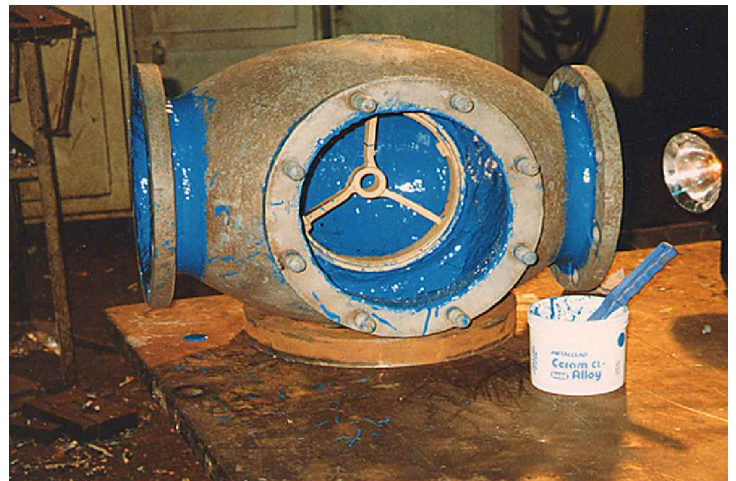
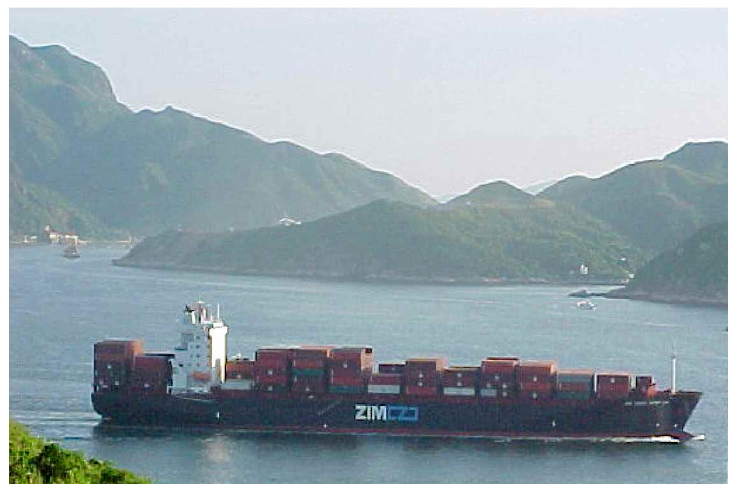
This sea water valve from a ZIM Line vessel was desperately in need of replacement. However, these valves were not available any more and "replacement" was no longer a viable solution.

After first grit blasting the valve, the holed areas were rebuilt using METALCLAD DurAlloy

and Reinforcement Tape. After only 20 minutes, the entire inside of the valve was rebuilt with CeramAlloy CP+. All internal (wet) areas were then coated with CeramAlloy CL+ to complete the repair.

The entire project took only part of a day to complete and was carried out in the Shipyard. On the following day, the ship inspector conducted a pressure test on the valve. Although normally requiring a pressure of 2 atmospheres in such testing, **the rebuilt valve was taken to 6 atmospheres and the results were perfect!**
