UK Refinery - One of the Largest in Europe - Salvages Badly Eroded/Corroded Pump With CeramAlloy & DuraTough

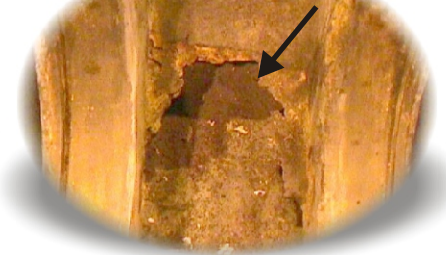
Note the severe damage...

large pump casing and impeller with ENECON CeramAlloy and DuraTough High Performance Polymer composites. Since it was determined that a significant cause of the damage to the guide

vanes (cutwaters) and impeller was cavitation attack, DuraTough was selected to be used in conjunction with the CeramAlloy on the guide vanes and impeller for added protection.

At this huge refinery in the United Kingdom, this severely damaged pump casing was ready for the scrap heap. However, Graham Wilson, the local ENECON Distributor, convinced the plant engineers to rebuild this

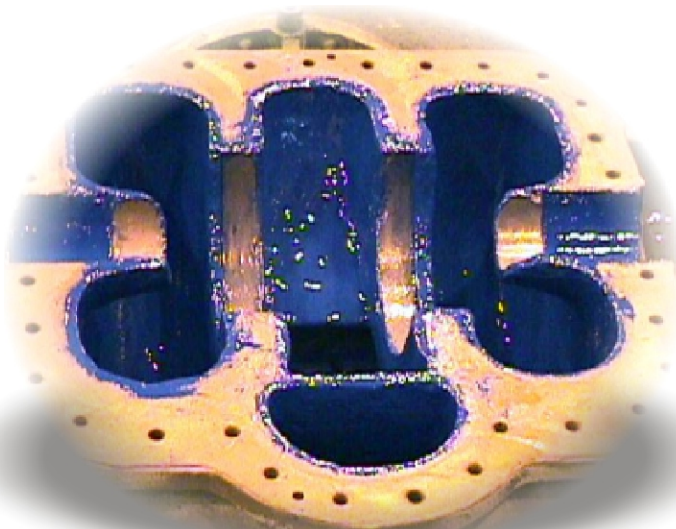
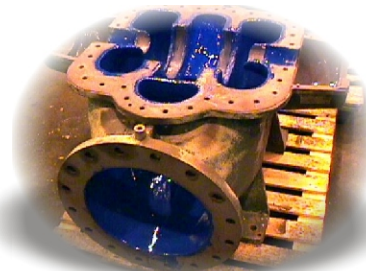
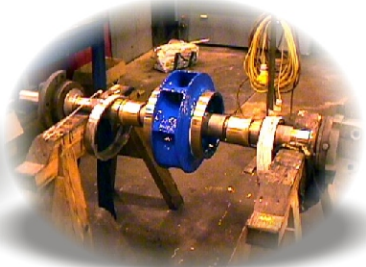
Inspected after 9 months in service, the rebuilt pump was shown to be in excellent shape and continues to perform perfectly.

The pump impeller and bottom casing after 9 months continuous duty, showing the DuraTough DL protection of the impeller surface is still in good condition.
