CeramAlloy CBX Provides Outstanding Protection to Coal Auger Trough at U.K. Power Station

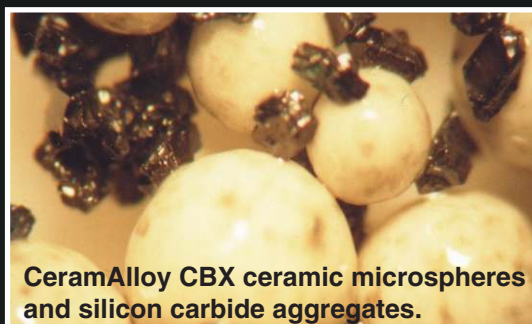
The plant engineers at a U.K. power station wanted to protect a coal auger trough with a high performance, abrasion resistant material that would withstand the tremendous impact and abrasion in the area under the feed hopper. This area normally received the most abuse.

The damaged area of the trough was cut out and replaced with a newly fabricated section. The engineers then selected CeramAlloy CBX to protect this critical section. The surface was cleaned and prepared with an angle grinder and then the CBX system was applied 1/4 inch (6 mm) thick over the entire section.

The trough was put back in service and seven months later, it was discovered that the *un-protected* sections of the trough had failed. During a scheduled plant shut-down, these damaged sections were replaced. New sections, which had been fabricated, were welded into place and CeramAlloy CBX was installed to protect these new sections as well.

By the way ... the initial application of the CBX was in absolutely 'perfect condition', according to the plant engineers.
