## DurAlloy & ENESEAL CR Salvage Fume Extraction System at Canadian Steel Mill Saving \$100k & Reducing Emissions

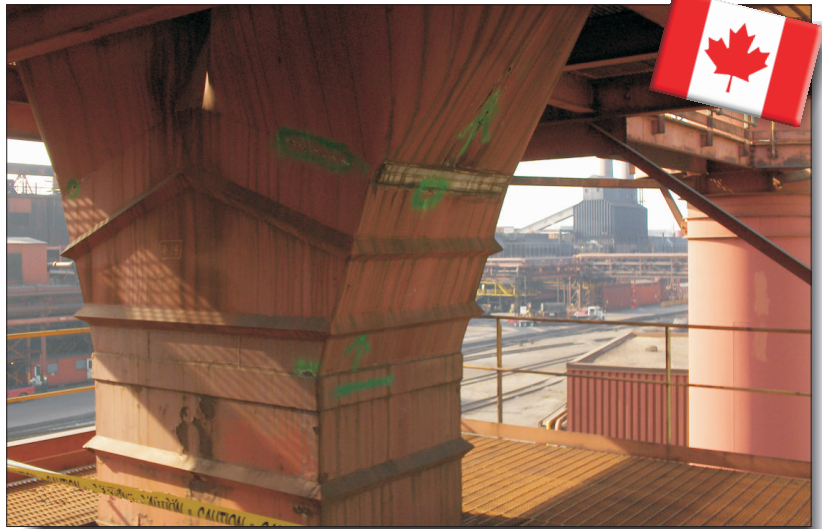
The maintenance personnel at this Canadian steel mill were struggling to patch holes in this fume extraction system. Holes cause loss of suction which, in turn, results in atmospheric emissions.

After years of carrying warm, wet, dusty and chemical laden fumes, the ducting was worn so thin that welded patches could no longer be applied without burn-through, warping and ripping. Silicone and caulking had been used with limited success.

The fume extraction system.

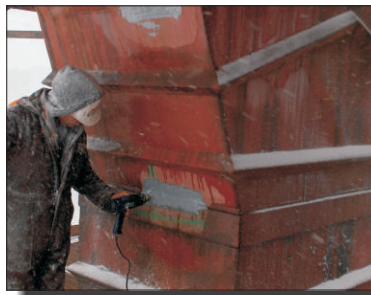
SpeedAlloy being applied.

ENECON Ontario was contacted to help find a fast and long lasting solution. Test patches of **SpeedAlloy** were applied to some of the duct's larger holes. The mill's engineers were so pleased with the results of the test patches it was decided that the entire duct section be encapsulated with

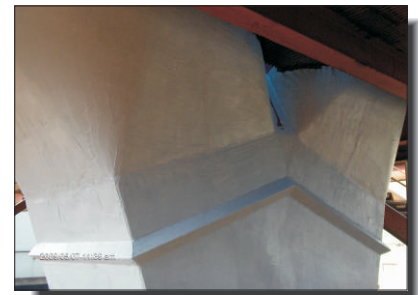
DurAlloy applied over entire extractor shell.

**DurAlloy**. As a final measure the unit was coated with **ENESEAL CR** for optimum corrosion resistance and a uniform look.

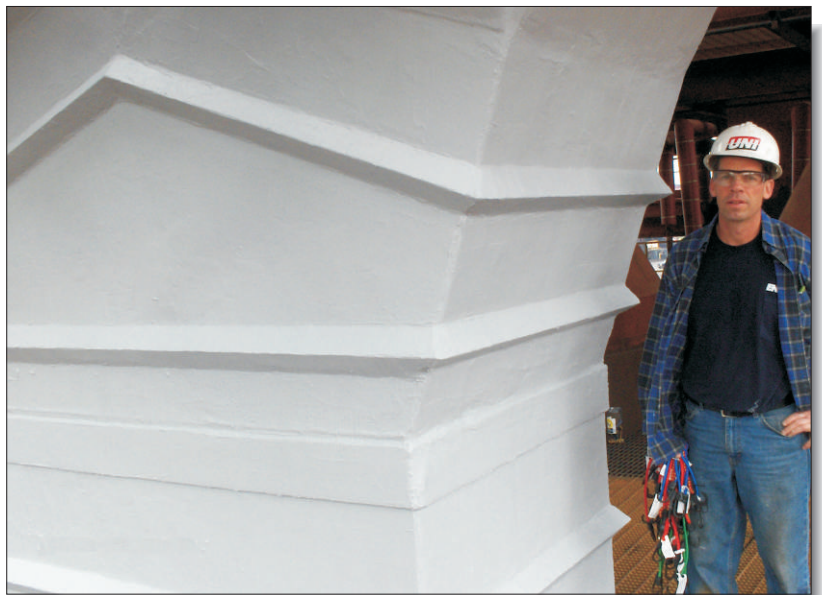
After totally encapsulating the unit in DurAlloy, ENESEAL CR was used to provide optimum corrosion resistance and a uniform look.

Instead, this fume extraction system was salvaged in two days for approximately \$15,000 saving the customer over \$100,000 and allowing the system to stay in service capturing atmospheric emissions without a major shutdown.
