## CHEMCLAD XC "Cures" Shower Stall Problems at New Jersey Hospital

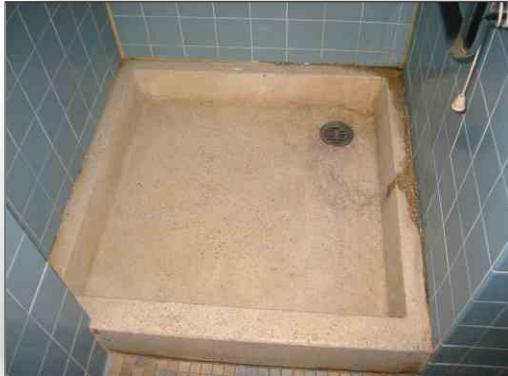
**Worn, pitted basins were unsightly & impossible to clean.**

After years of constant use, the basins had become worn and pitted and the original sealer finish was gone. The basins were nearly impossible to clean and unsightly as well. Patients were reluctant to use the showers. Since occupancy is as important to a hospital as to a hotel, each shower had to be completed in one day as rooms became available.

The solution was the application of CHEMCLAD XC, tinted to the color (blue) selected by the hospital staff to compliment the wall tile color.

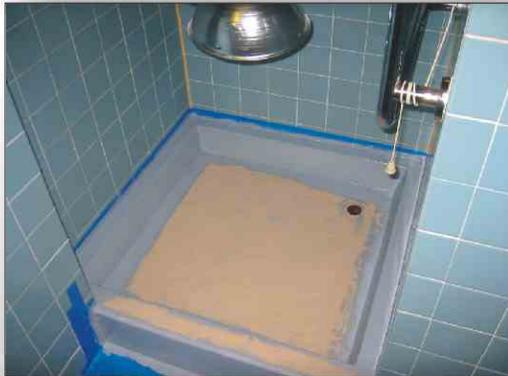
**Heat lamps were used to accelerate the cure of the first layer of CHEMCLAD XC**

A first layer of CHEMCLAD XC was applied by brush and roller. An anti-slip aggregate was broadcast into the uncured CHEMCLAD XC. This filled in pits in the concrete surface and improved the safety of the showers. After sweeping up the excess aggregate, a second layer of CHEMCLAD XC in the finished color was applied.
