This pump pedestal at a pulp and paper mill in Quebec, Canada, was virtually destroyed by the acetic liquid being pumped.

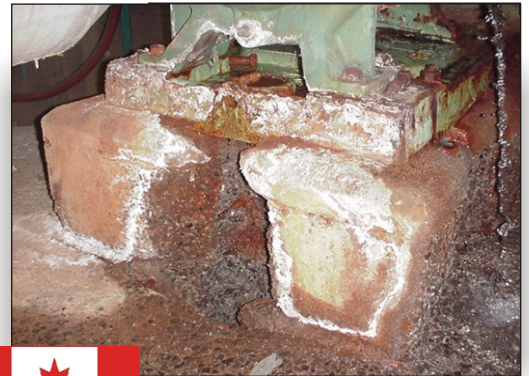
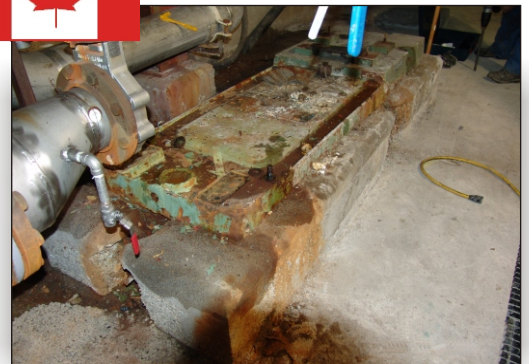
The pump was removed and sent out for grit blasting during which time the pump pedestal was completely rebuilt with DuraQuartz.

After the pump was put back in place and aligned, more DuraQuartz was used to grout-in the entire pump unit. Additional DuraQuartz was then used to fill the gap between the pump and the pedestal. In this way, the acetic liquid would not get under the pump and attack the concrete pedestal in the future.

Two coats of CHEMCLAD SC were then applied over the entire pump assembly including the pedestal to provide long-term corrosion protection. This entire project cost about \$10,000. A conventional repair and replacement alternative would have cost more than double.
