Canopy Roofs at US Air Force Base Protected With ENESEAL

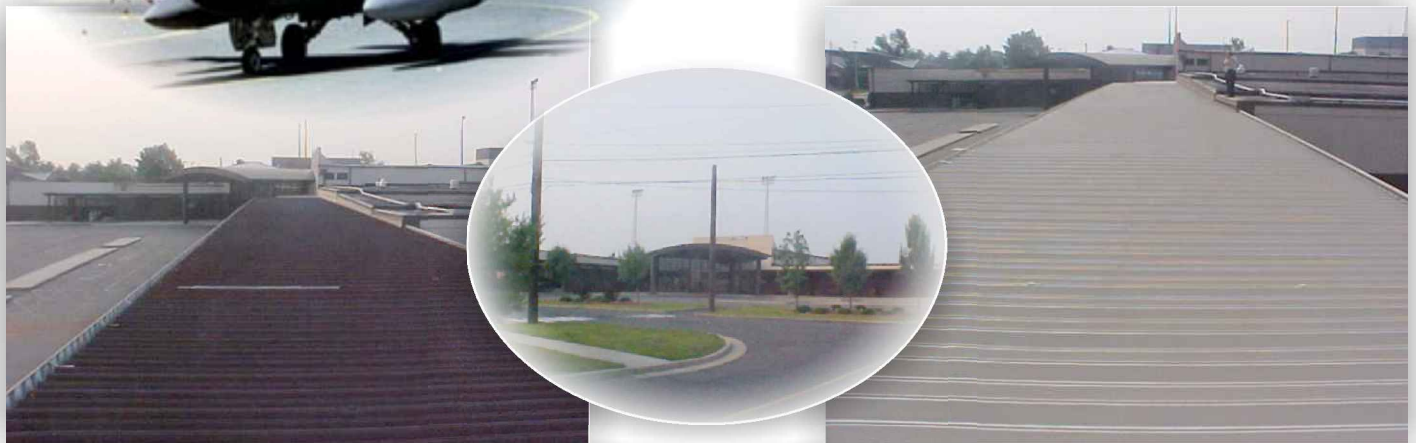
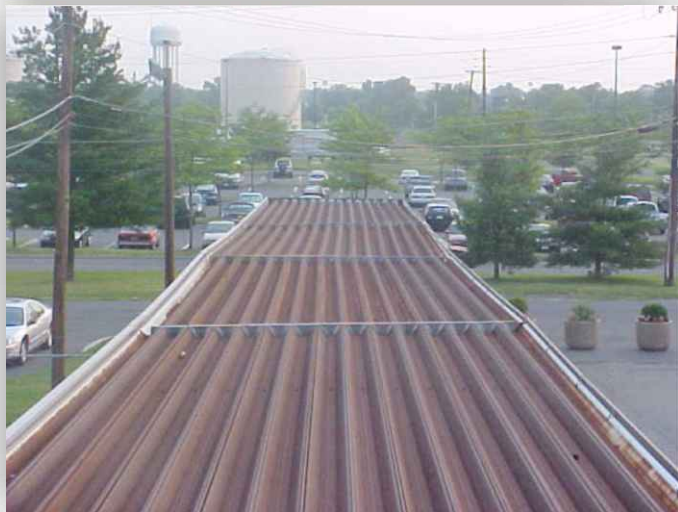
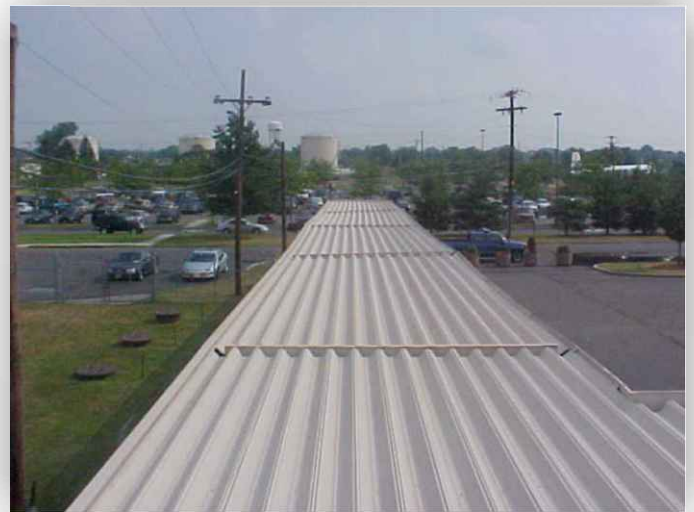
These metal canopy roofs of the passenger terminal at a major US Air Force Base had deteriorated badly because previously applied conventional paint systems provided only limited protection. Jet fumes contributed to the paint system's failure and

to the subsequent corrosion problems.

engineers turned to the ENECON Mid Atlantic Engineering Team for help. The cost effective solution: protect the canopies with the ENESEAL HR heat refractive system.

The metal canopy roofs

were grit blasted, then primed and sealed with the ENESEAL system. The Air Force Base is completely satisfied with the outstanding results.
