ENECON Italia Solves Cavitation Problems For Ferry Boat Operator

*Cavitation problems
on a ferryboat's
salt-water discharger
repaired and protected
from future attack with
DuraTough DP & DL*

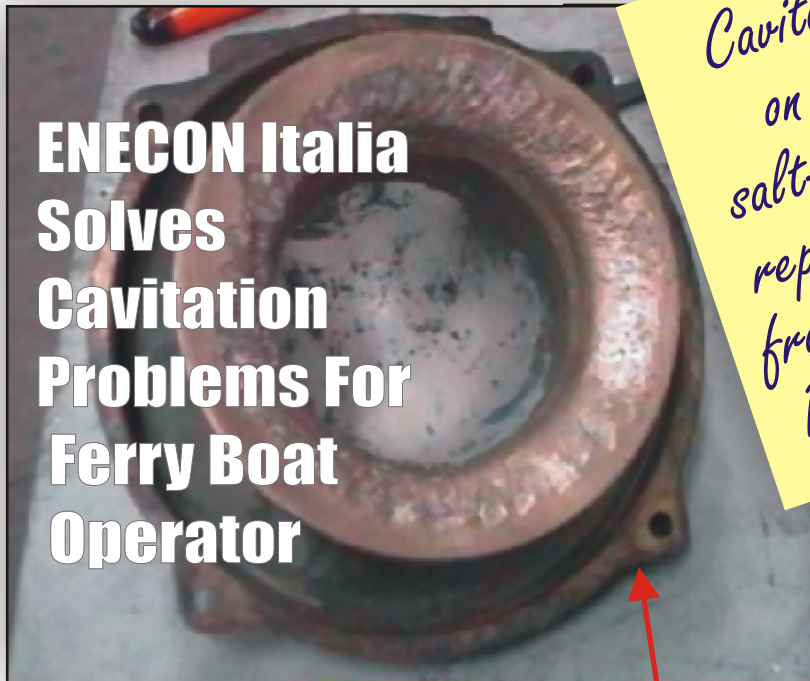
Severe cavitation damage clearly evident on discharger after grit blasting/cleaning.

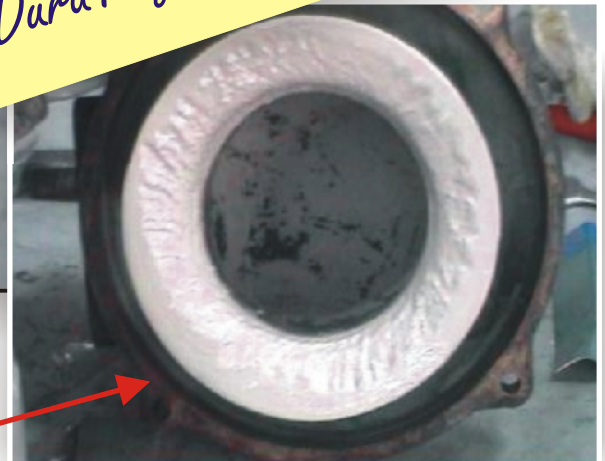
DuraTough Primer applied to the prepared surface.

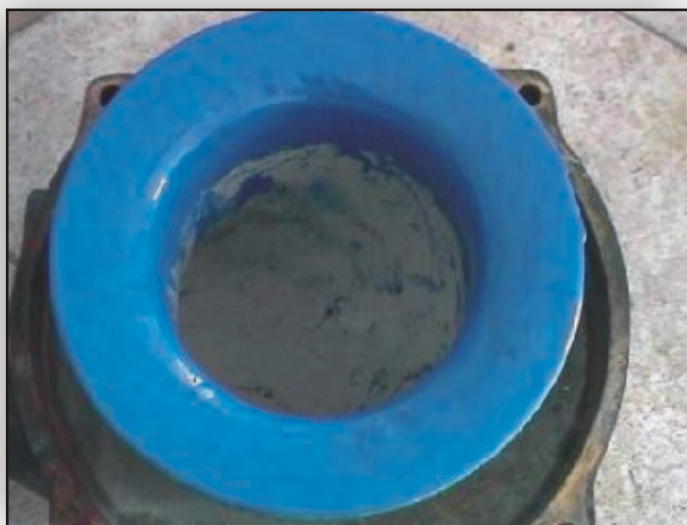
DuraTough DP applied to re-build damaged surface.

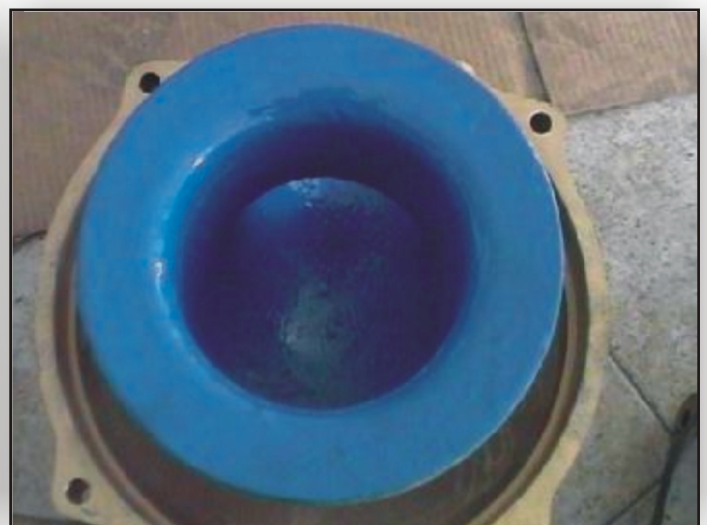
DuraTough DL applied to completely seal and protect the discharger.
