## Repair v. Replacement

### The Cost Effective Solution

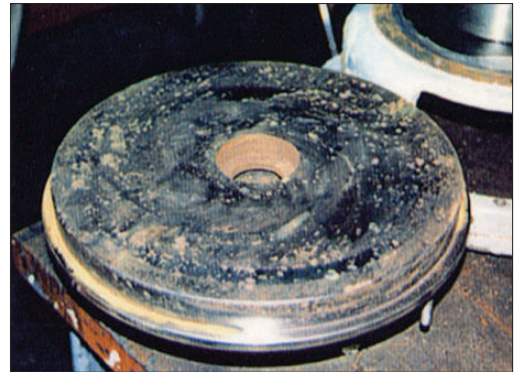
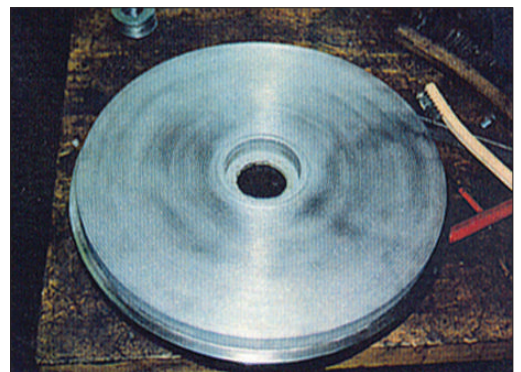
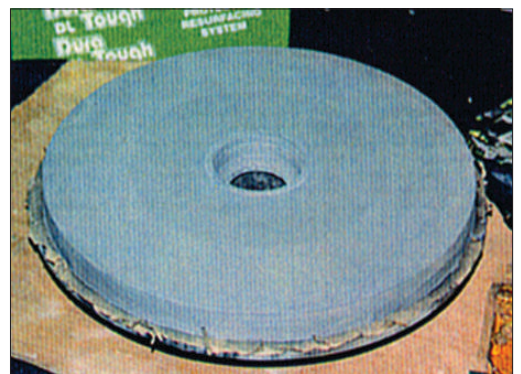
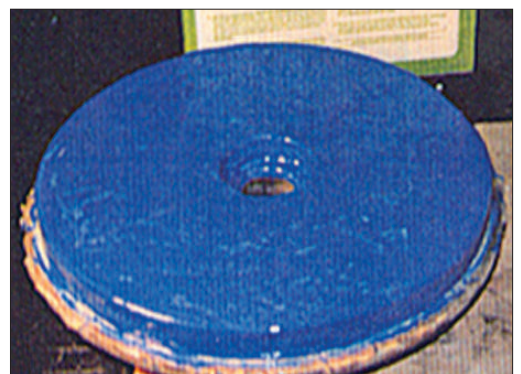
The maintenance supervisor and his crew had a damaged pump from their service water system disassembled and on the workbench. The back plate of the pump had severe cavitation damage; and, to make matters worse, the pump shaft was also badly scored in the bearing area.

Faced with replacing not only the expensive back plate this time, but also the stainless steel pump shaft,

The damaged back plate was first machined down and “grooved” and then rebuilt with DurAlloy to the desired dimensions and contours. The plate was then coated with the DuraTough system to extend its service life.

On the pump shaft, the damaged area was undercut and threaded. DurAlloy was then applied and machined down after cure to the necessary tolerances.
