Nuclear Power Station Finds ENECON The Best Solution For Critical Shaft Repairs

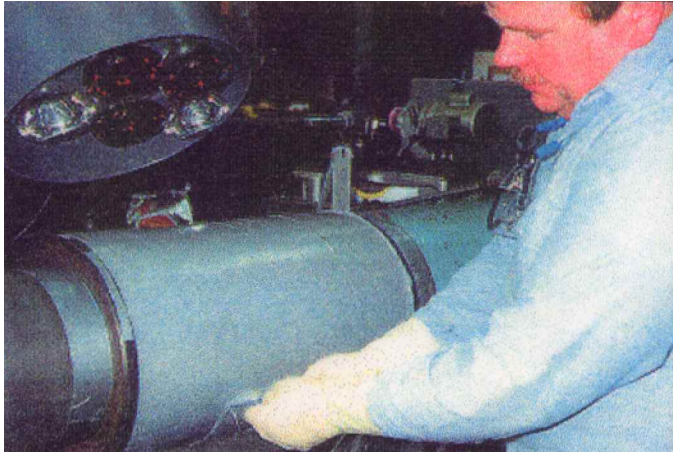
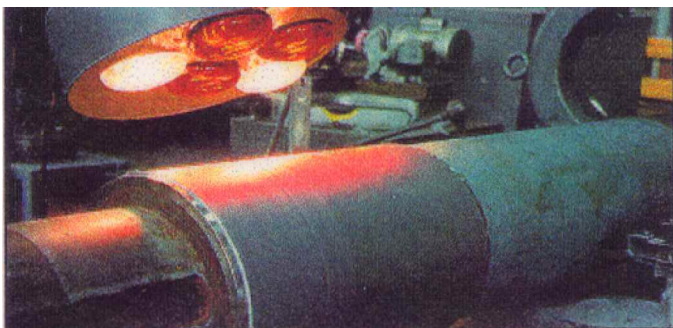
This 13.5 inch diameter pump shaft was brought into the central repair facility of a large Northeastern utility when it was found to be badly scored.

The shaft was put on the lathe and a rough "screw thread" pattern was machined into the repair area. To insure that there were no low spots in the DurAlloy as it was applied, sufficient thicknesses of tape were put on the shaft just outside the repair area to serve as a thickness

guide for the DurAlloy build up.

DurAlloy was applied with the lathe turning slowly to draw the material from the applicator. The initial material was pressed in well, followed by additional DurAlloy to overbuild the surface and allow sufficient material for machining. Using the tape at the ends of the repair area as a guide, a straight edge was then used to insure that there were no low spots in the DurAlloy and also to leave a uniform overbuild to facilitate the subsequent machining operation.
