U.S. Aircraft Carrier Seals Leaking Hatches on Flight Deck

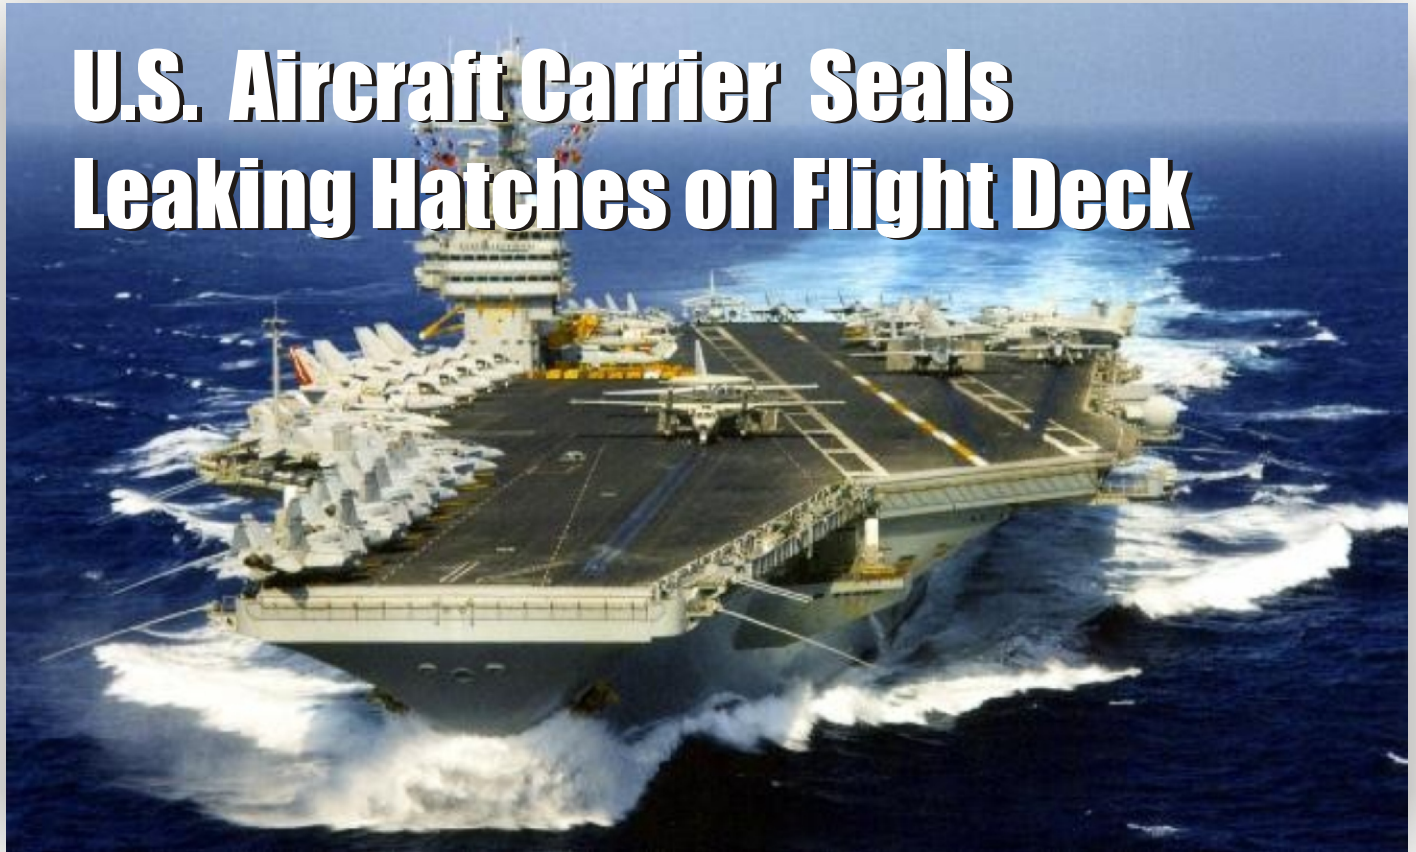
The Auxiliary Electric Start Systems (AESS) lockers on an aircraft carrier provide the ability to “jump start” a fighter plane if required. The hatches are flush with the carrier deck and are designed to keep water and other contaminants from getting into these lockers – potentially compromising the operation of the electrical systems.

What often happens, however, is the gasket retainer corrodes due to constant immersion in saltwater, fuel, hydraulic fluid, etc. As a result, the hatches leak and the AESS lockers can fill with water. This is not a good thing.

A conventional welding repair is time-consuming and sometimes damages the hatches. The ship’s engineers decided to utilize a

more “high-tech” approach. The damaged areas were repaired with **DurAlloy** then sanded smooth to the desired shape and dimension. Two coats of **CeramAlloy CL+ [AC]** were then applied over the entire seal area to provide long-term corrosion protection to these hatches.
