## DurAlloy Stops Critical SF-6 Gas Leaks

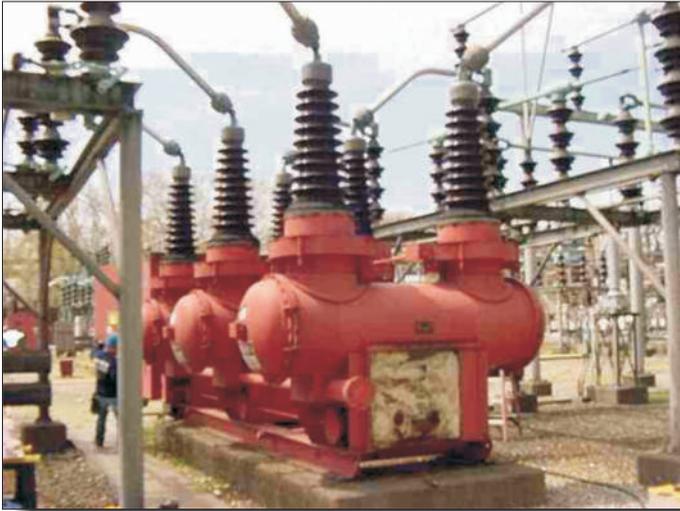
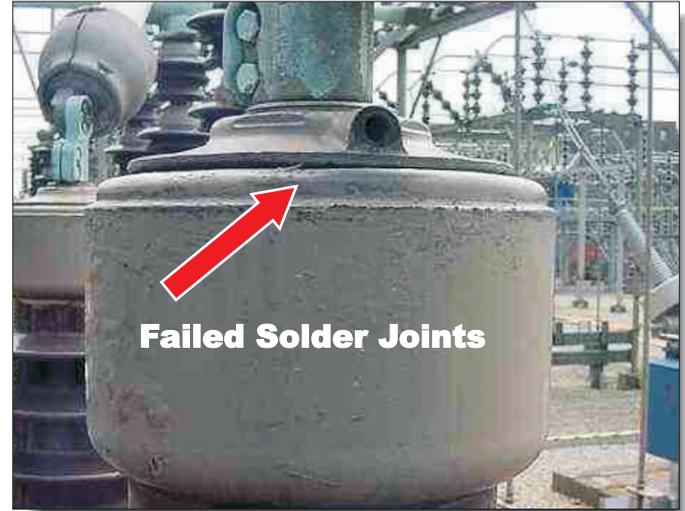
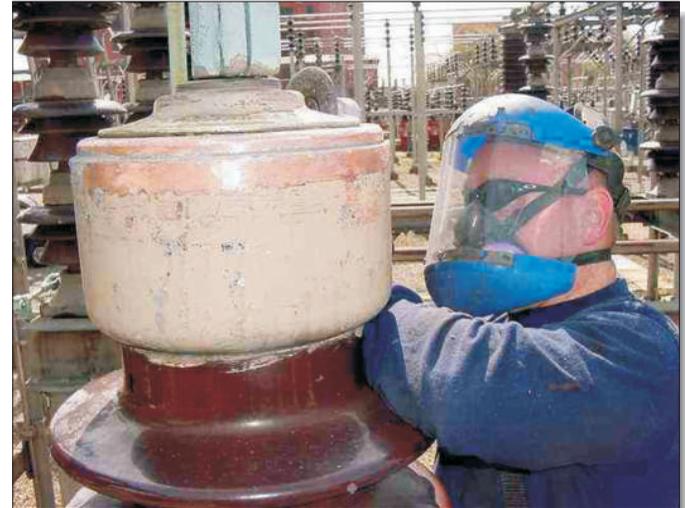
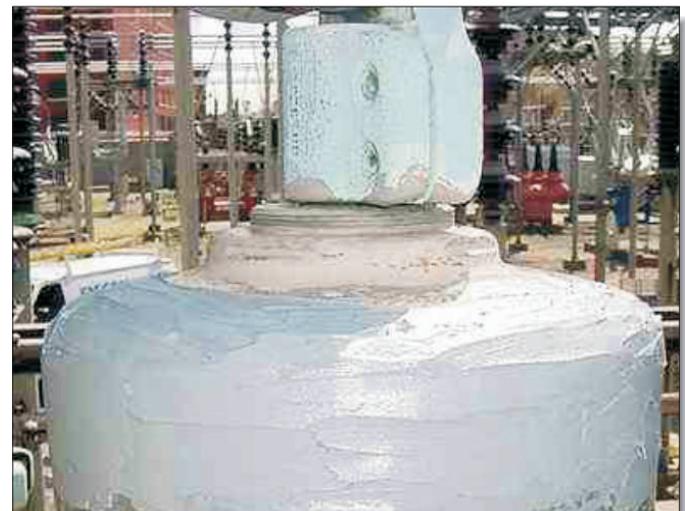
A major Northeastern U.S. utility company was experiencing SF-6 gas leaks on its substation breakers. Cracks in the old solder joints were causing this gas to leak from the insulator bushing caps. SF-6 gas has excellent cooling and insulation capabilities. However, SF-6 gas is an expensive and ozone-depleting gas so leaks are unacceptable.

First, the old solder and paint were stripped away from the bushing caps. After a thorough cleaning, DurAlloy was applied to completely seal the failed joints.
