## CeramAlloy CBX Outperforms Rubber Liner & Hardface Welding

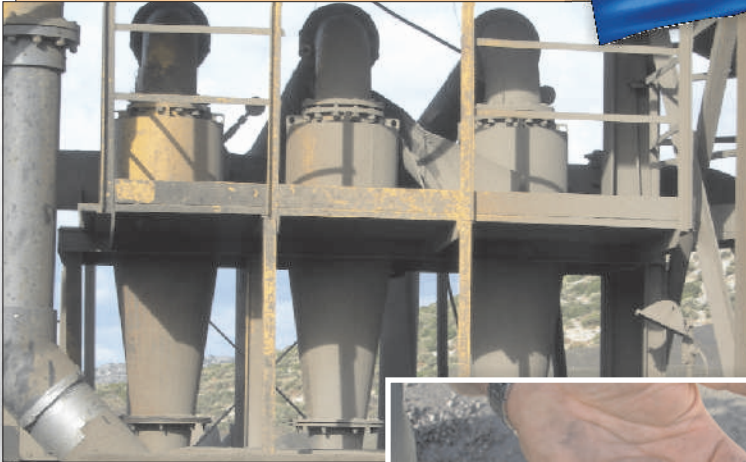
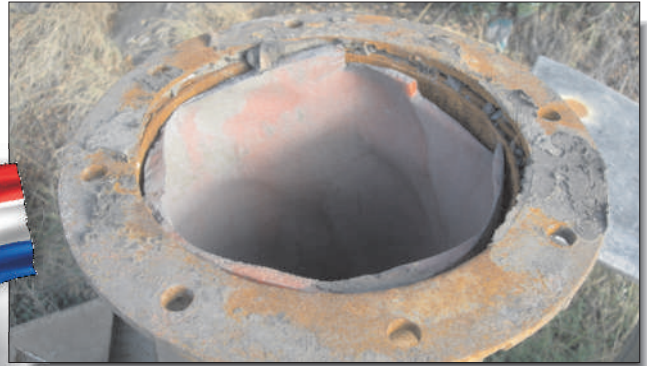
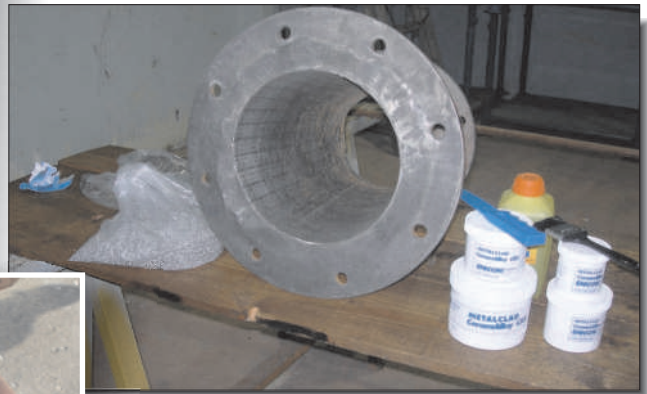
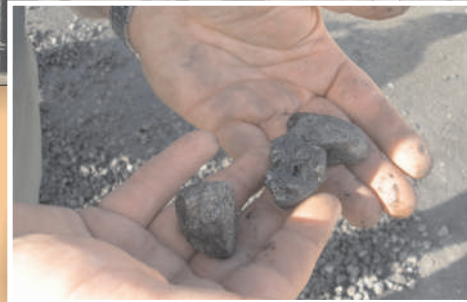
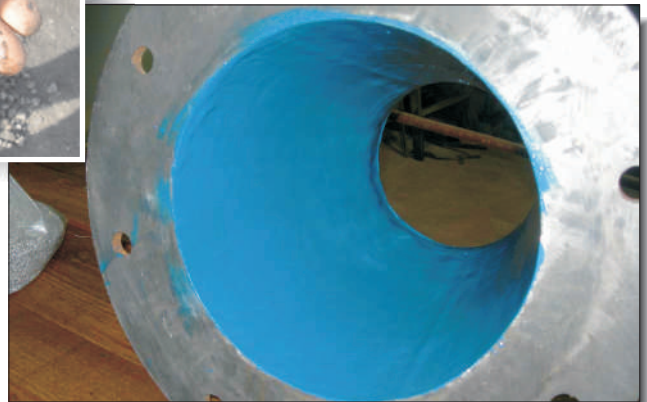
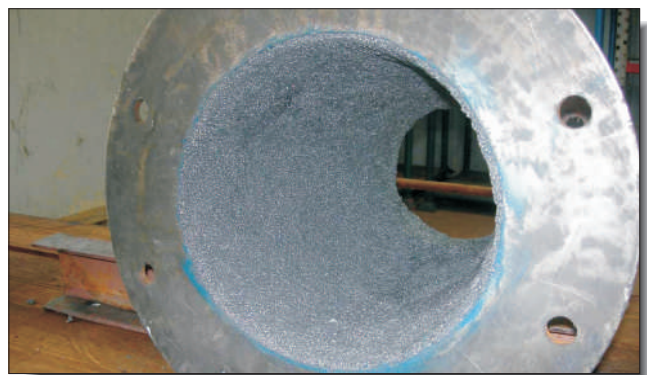
A local municipality on the Adriatic Sea in Croatia wanted to move a welding manufacturing plant from its seaside location to another site further inland. However, as part of this move, they were required to dispose of thousands of tons of slag which contained Silicon Manganese and Ferro Manganese, both of which have high re-sale values when separated. In order to do this effectively, these two metallic materials needed to be separated from the slag through cyclone separators - which typically must be repaired every month.

The plant engineers wanted to see if they could find a more durable repair material so they conducted a side-by-side test utilizing a rubber liner for one

cyclone, hardface welding on another and CeramAlloy CBX on a third cyclone.

After three weeks the rubber liner and the hard-facing had both failed but the CBX was still providing excellent protection. The engineers selected our CBX as their standard repair material for this demanding application and immediately coated three additional spare cyclones.
