Waste Water Treatment Plant Salvages 'Unsalvageable' Pump Suction Housing with CeramAlloy

Client: Waste Water Treatment Facility

Location: Southwest Florida

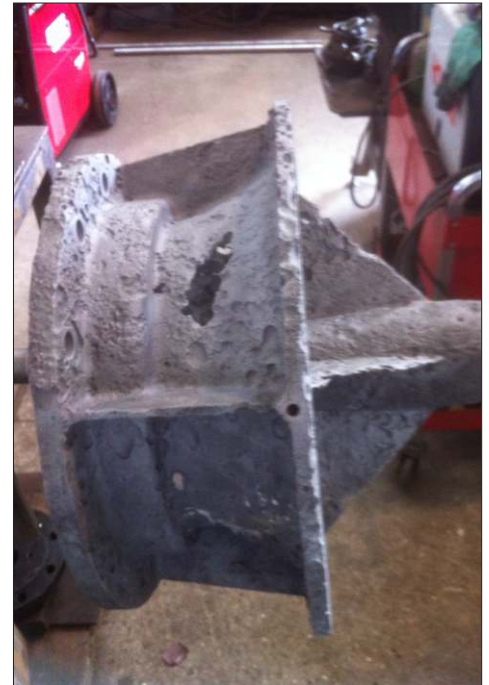
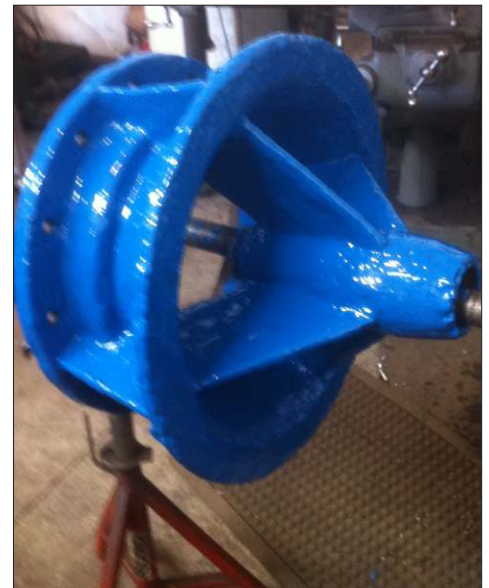
Problem: Severely eroded & corroded pump suction housing.

Solution: Grit blast – repair all eroded areas back to original shape and profile with CeramAlloy CP+AC. Reinforcement mesh was used to bridge holed or severely eroded areas. Two coats of CeramAlloy CL+AC were then applied to completely encapsulate the casing to protect it from future erosion and corrosion damage.
