Oil Company in Thailand Repairs 22 'Problem Areas' with DuraWrap

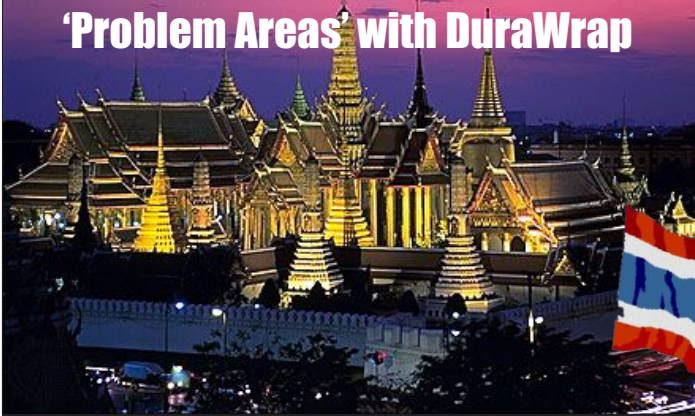
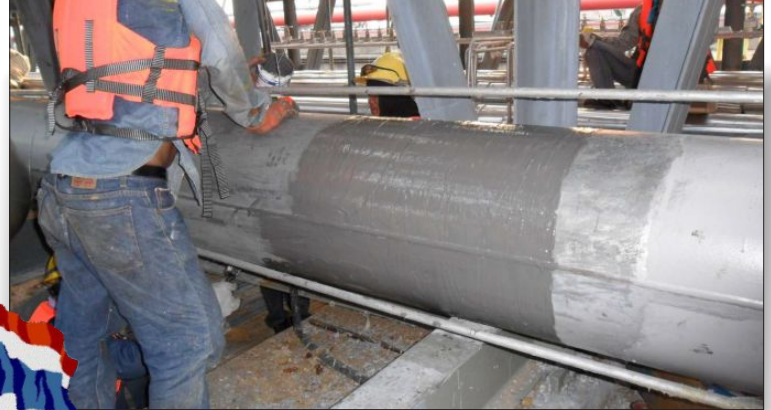
Problem: 20" diameter pipe was severely rusting in 22 different locations.

Solution: Original galvanized coating was removed. Rusted areas were manually prepared by grinding and wire brushing. *DurAlloy* was used to repair any damaged areas on the pipe. *DuraWrap Primer* was applied followed by two layers of *DuraWrap Carbon Fiber System*.
