Wastewater Treatment Facility Located in the Pacific Northwest

Protects Digester Roof Insulation With ENESEAL HR

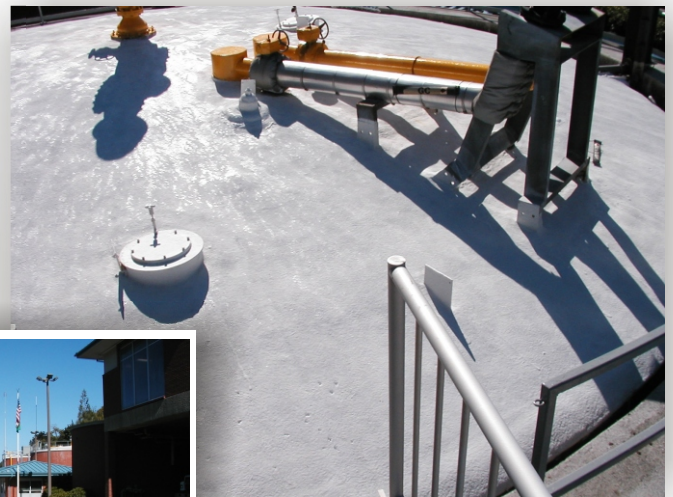
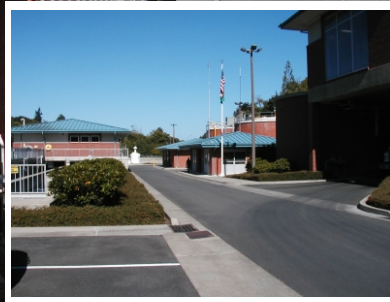
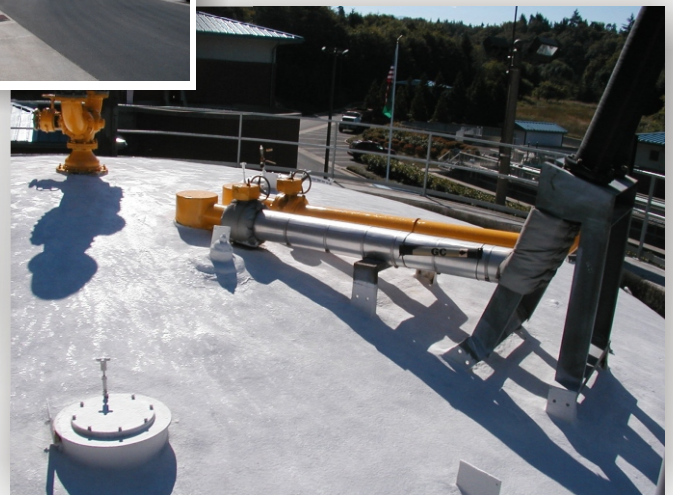
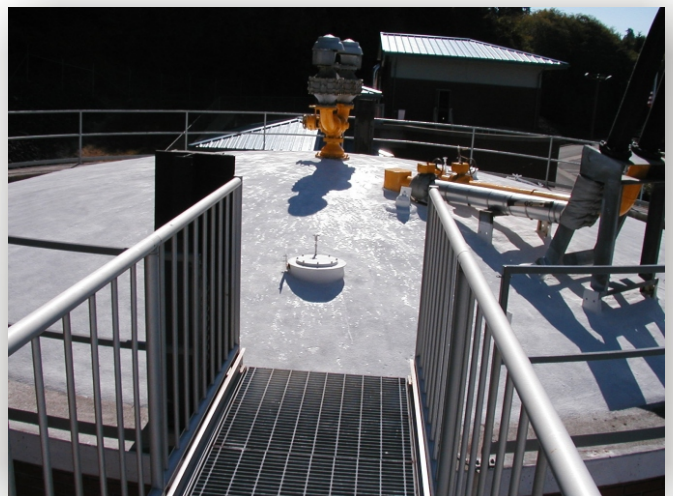
"Over the years, the insulation on the plant's digesters had been compromised in a number of areas and was becoming saturated with water. As a result, it was deteriorating at an accelerated rate and was diminishing the efficiency of their operating unit. If a solution was not provided, the insulation would have continued to deteriorate and would have eventually needed to be replaced – a

very costly procedure, as you can imagine.

Consequently, the plant's Wastewater Treatment Supervisor elected to take a 'proactive' preventive maintenance approach and utilize ENESEAL HR to protect the insulation – *at a fraction of the cost of replacing the insulation if it had been allowed to continue to deteriorate.*

The on-site staff of the wastewater treatment plant applied the ENESEAL themselves and are extremely satisfied with its performance."
