After 10 Years in Service on a 680 ft. Alaskan Fish Processing Ship CeramAlloy Coated Pump Impellers Look Like New

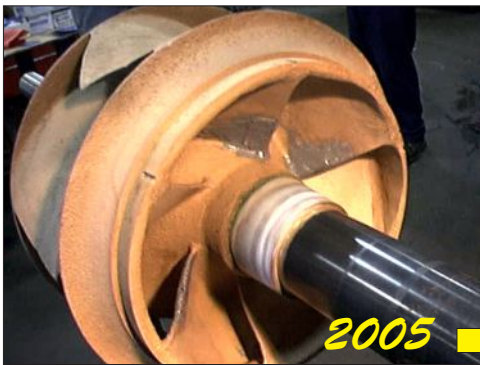
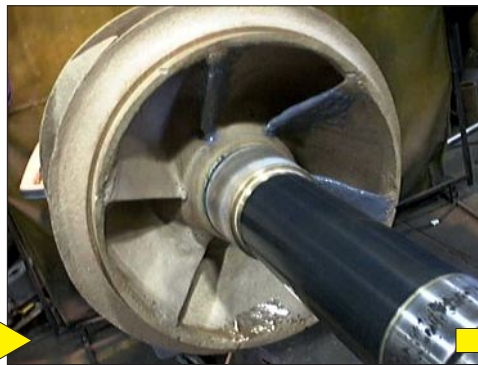
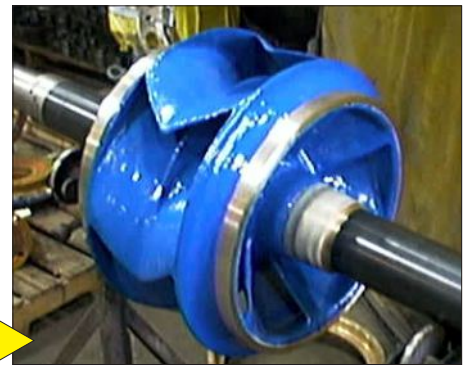
In 2005, ENECON was contacted to repair and protect an impeller for a large split case cooling water pump. Because of its outstanding performance in erosion / corrosion environments, CeramAlloy was selected to complete these repairs.

After grit blasting, the severely damaged leading edges of the vanes were rebuilt using stainless steel mesh and CeramAlloy CP+AC. The entire impeller was then protected

with two layers of CeramAlloy CL+AC.

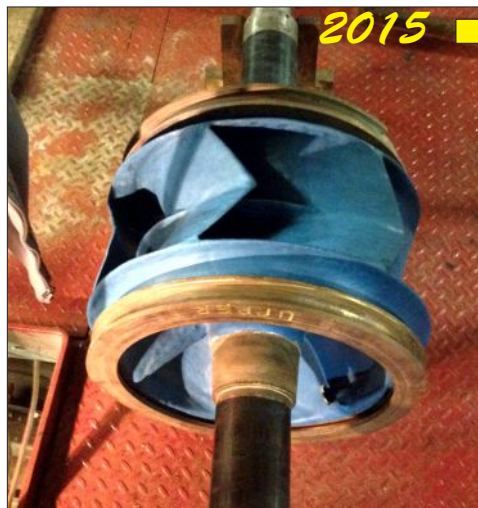
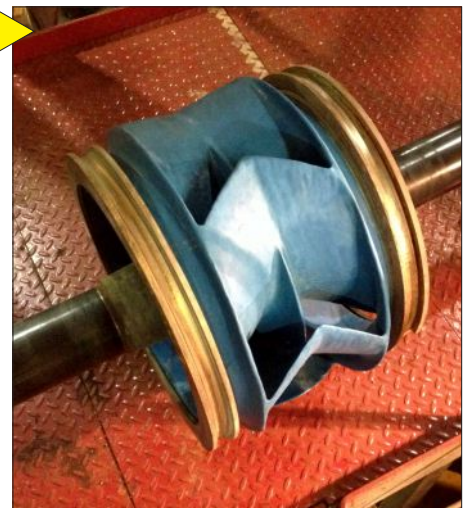
Although the vessel's maintenance logs confirm that the impeller did not have any maintenance performed for

10 years, it is clear from the photos below that the CeramAlloy is still in excellent condition.
