## DuraWrap Repairs Power Plant Cooling Tower Supply Line

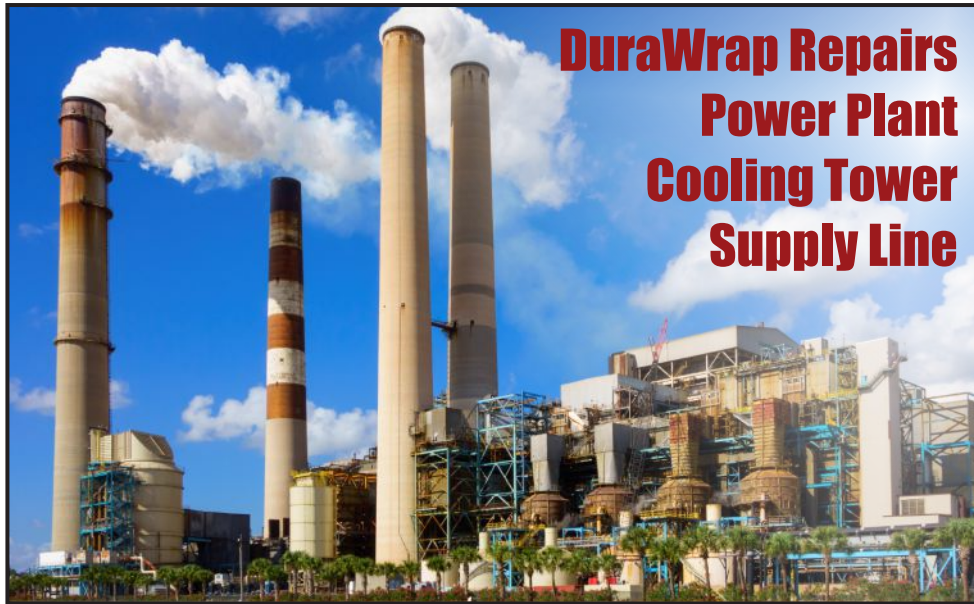
This 24 inch diameter intake pipe, located at a U.S. Power Plant, was leaking above the ground just below the disc valve. The plant's maintenance engineers needed a proven, reliable and economical solution to this problem.

The local ENECON Distributor was called in to develop a solution. First the exterior surface of the pipe was 'bristle blasted' to promote maximum adhesion by removing all existing failed coatings and corrosion.

Once the preparation was completed, a 12 x 12 x 1/8 inch thick curved steel plate was prepared and 'cold welded' over the holed area of the pipe using ENECON's DurAlloy.

That was followed by the application of two layers of the DuraWrap Carbon Fiber Pipe Wrap System. CeramAlloy CL+AC was then applied to the entire area as a final layer.
