## International Medical Products Manufacturer Repairs Critical HVAC Component with CHEMCLAD XC & SpeedAlloy

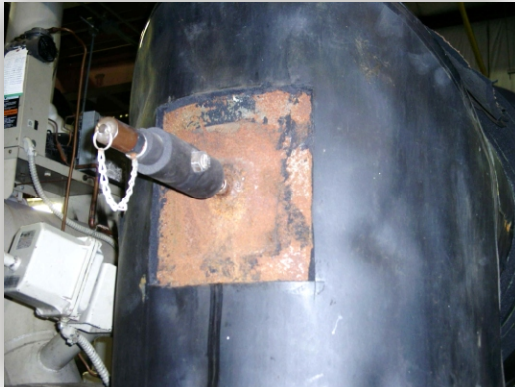
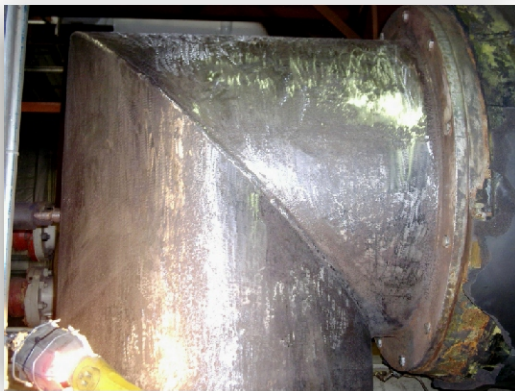
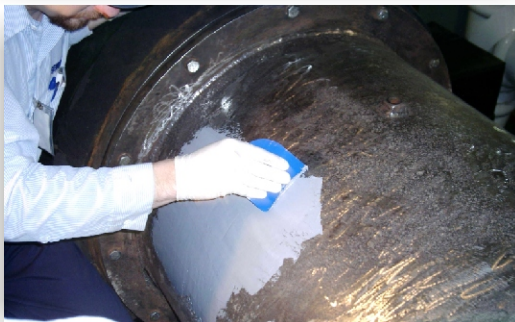
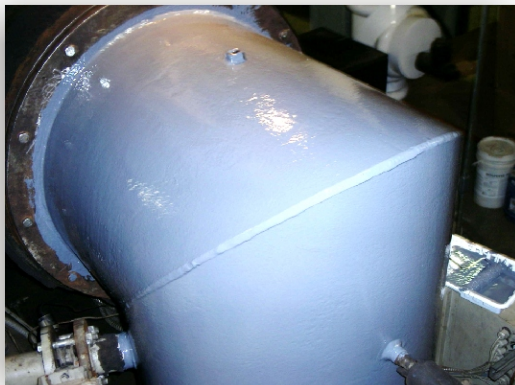
The maintenance engineers at this large medical products manufacturer in Delaware discovered that they had a problem with the elbow of this vacuum chiller that is used to produce ice to supplement the cooling process at one of their facilities.

The rubber insulation of the elbow was stripped away. The surface was manually prepared by rotary filing, grinding and sanding. The entire area was then thoroughly cleaned with Alcohol.

SpeedAlloy was applied to fill and seal any small pinholes in the elbow which were causing the vacuum leaks. Finally, two coats of

CHEMCLAD XC were applied over the entire elbow to provide long-term corrosion protection to this critical HVAC component. It was then re-insulated.
