ENECON Italia Flies In To Repair The Decks On This Tanker In The Adriatic Sea

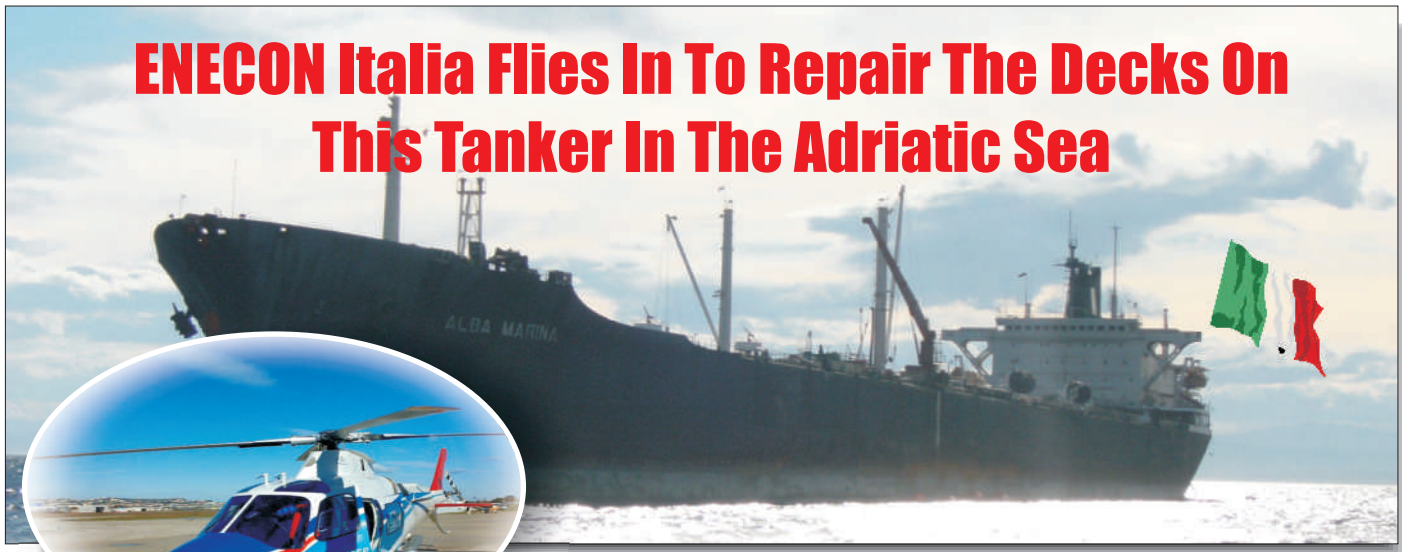
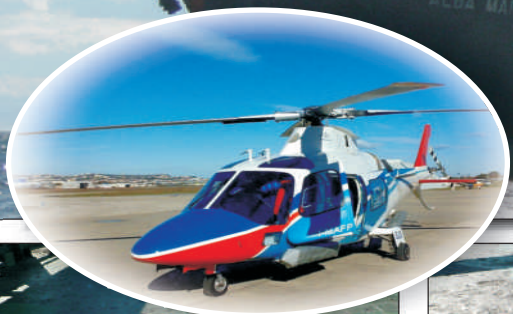
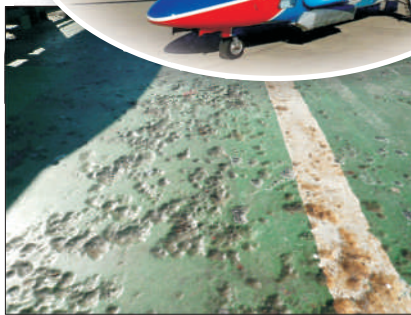
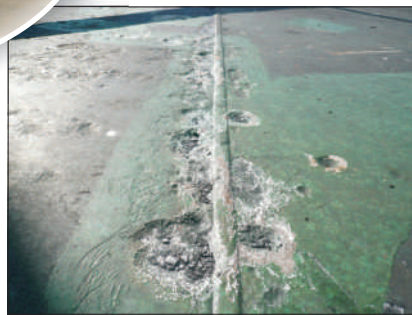
This oil storage tanker ship is permanently moored off the coast of Italy and supplies oil to a local power company. The ship is 30 years old and needed to be re-certified by the Italian ship inspection registry RINA in order to be able to continue in service for another 5 years.

The deck was badly pitted from seawater corrosion and the RINA inspectors informed the ship's owners that it needed to be repaired and protected before they would re-certify the vessel.

DuraFill with locally sourced aggregates was suggested as a cost-effective method to repair and fill all of the pits in the steel deck followed by an application of CHEMCLAD SC with non-slip aggregates to provide long-term corrosion protection to the deck as well as a slip-resistant surface.

About half of the 21,000 sq.ft. of decking has already been repaired and protected.
