Maryland Hotel Selects DuraQuartz & FPS 2000 to Repair & Protect Busy Walkway

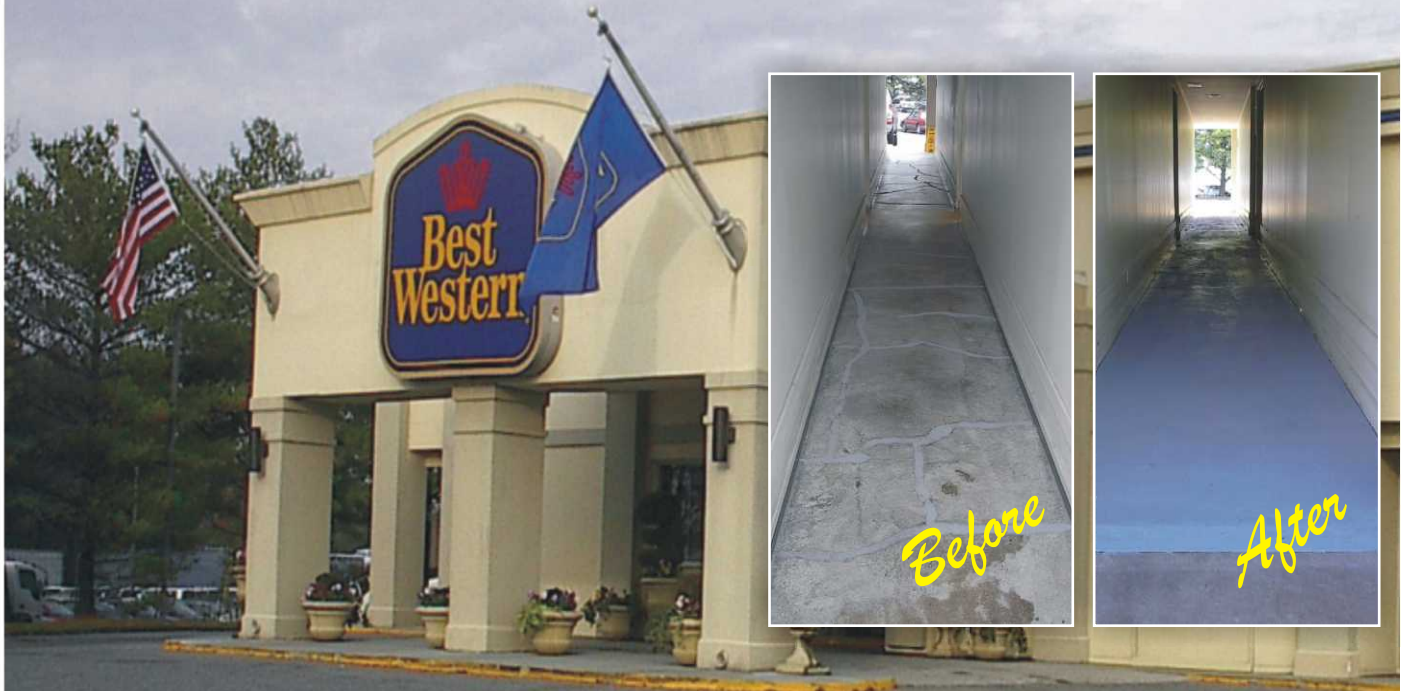
This hotel in Maryland was confronted with a potentially costly as well as disruptive problem for guests and staff. The walkway pictured above had been covered with a rubber runner for a long period of time. When the runner was lifted off the walkway the hotel management discovered severe cracking to the walkway surface.

Since the walkway was generally sound, he suggested that all the cracks be repaired with ENECRETE DuraQuartz and then the entire walkway should be sealed and protected with ENECLAD FPS 2000.

The walkway was first cleaned and prepared by grit blasting.

DuraQuartz was used to fill, repair and level all the cracked areas. FPS 2000 was then used to seal and protect the entire walkway from future deterioration.
