Rudder Pintle Housing Repair with DurAlloy Eliminates Expensive Machining Operation In Israel

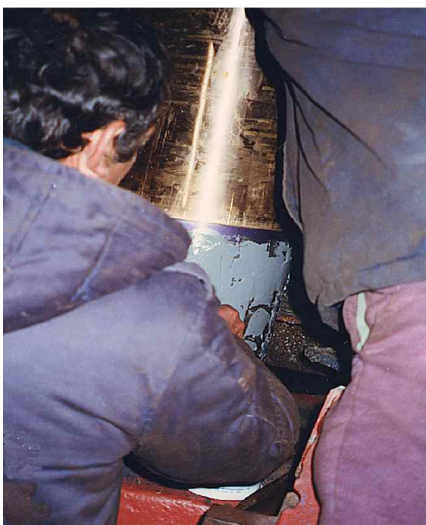
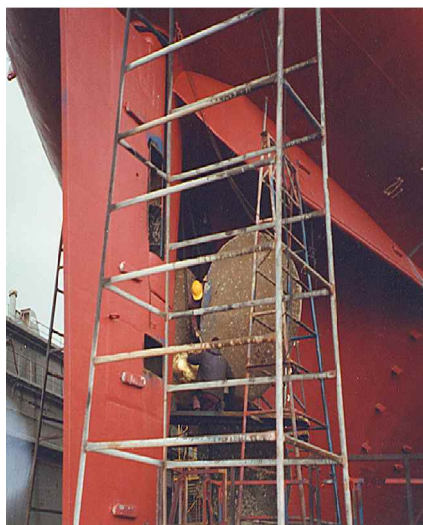
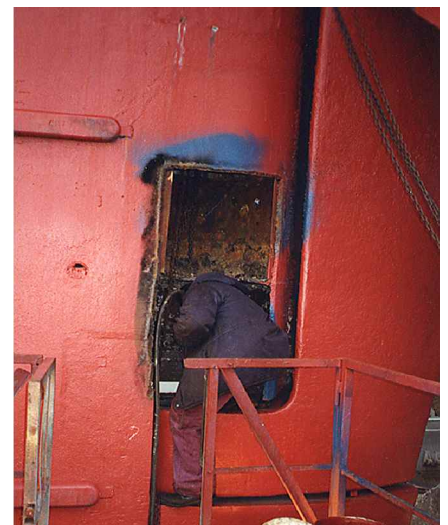
During a dry-docking, the rudder pintle housing on the ship Galia Carmel was found to be severely corroded from the salt water. The normal repair procedure of welding and line boring of this tapered housing would have necessitated numerous man hours as well as the cost of expensive in-place machining techniques and equipment.

After surface preparation, the DurAlloy was applied to both the housing and the pintle (previously coated with Release Agent) and reassembled, rebuilding the housing and protecting the area from further corrosion.

using ENECON DurAlloy to rebuild the housing. And, by using the pintle to **form the housing to the desired dimensions**, the need for a subsequent machining operation would be eliminated!

After reviewing and witnessing the application, the repair was accepted by the Lloyd's Surveyor upon completion.
