## Power Plant Repairs Manhole Access Covers On Main Cooling Water Intake Lines With CeramAlloy, CHEMCLAD And Some “Imagineering”.

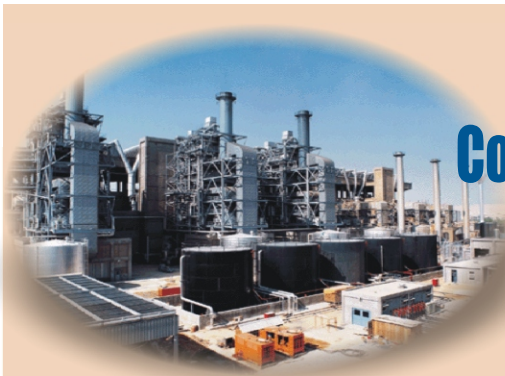
These two concrete manhole covers over the power station's main cooling water intake lines were in very poor condition. It was impossible to keep these sealed. So much water was leaking through the covers that sump pumps had to be used constantly in order to keep the pit from filling up with water.

*New steel necks – larger than the O.D of the concrete flanges – will be fabricated. The new steel necks will slip over the existing concrete flanges and will be bonded to the concrete using ENECON CeramAlloy CP+AC. The CP+AC will be used to fill in the areas around the neck insuring a complete bond and seal to both the steel and the concrete...*

*The concrete surfaces will be abrasive blasted to create a suitable anchor profile for bonding. All steel surfaces will be grit-blasted to an SSPC SP-10 (near white metal) finish with a 2 - 3 mil profile. All prepared metal and concrete surfaces will receive a final two-coat layer of ENECON CHEMCLAD SC...*

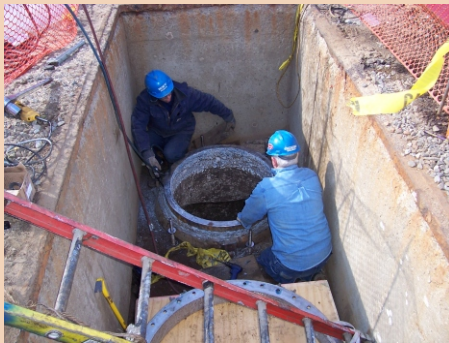
*“The concrete areas where the manhole covers and the pipes meet are in very poor condition.*

The plant engineers turned to ENECON North East for help. The following proposal was submitted and approved. This \$20,000 project was completed in just a few days to rave reviews by the plant personnel.
