## Engineers at a Waste Water Treatment Plant Located in Philadelphia Repair Leaking Pipe Elbow with CeramAlloy

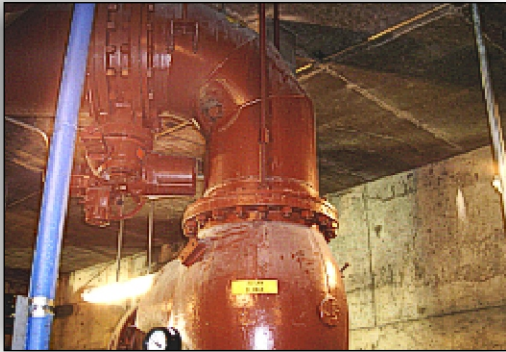
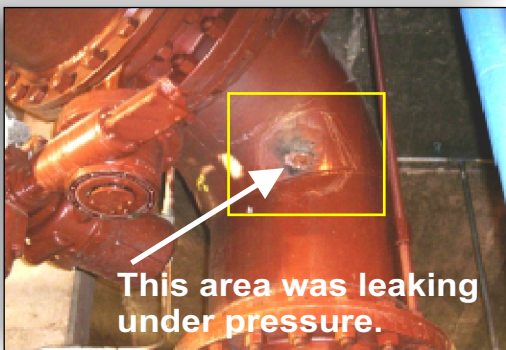
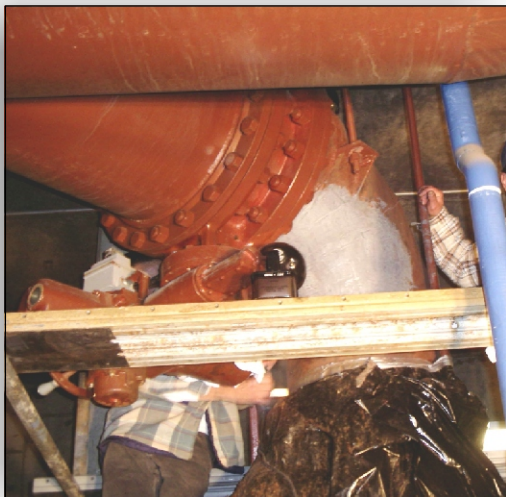
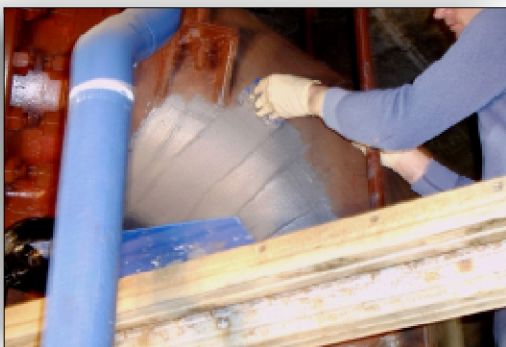
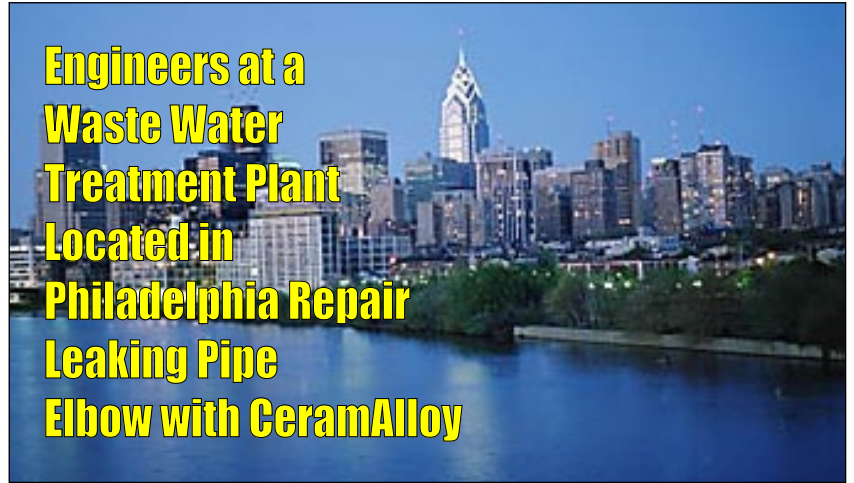
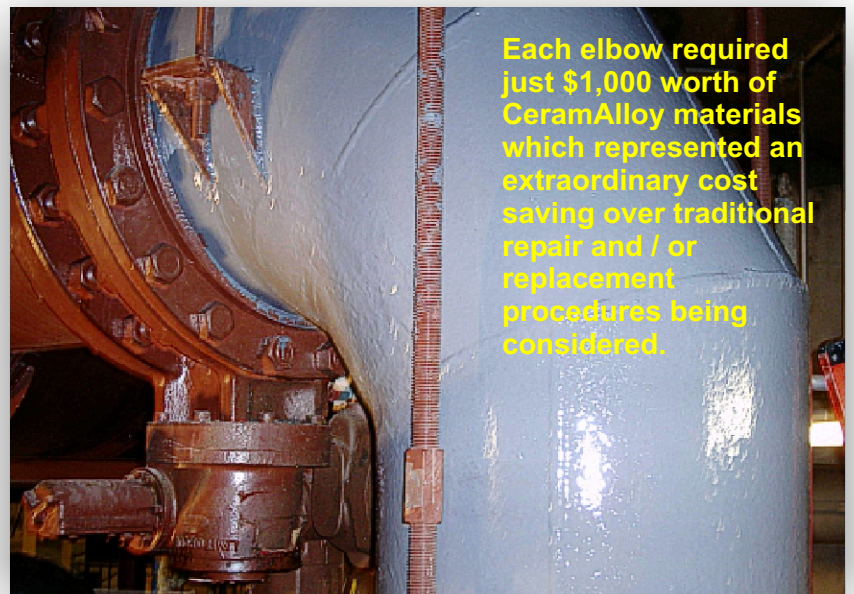
The maintenance engineers at this municipal waste water treatment facility needed a quick as well as cost effective repair on 8 RSP (Return Sludge Pump) exit elbows that had developed leaks. Removal and replacement was an expensive and time-consuming option that would have left the plant vulnerable

to systems overload and possible shut-down.

ENECON engineers suggested an unconventional solution: repair and rebuild the elbows with CeramAlloy CP + AC and CL + AC.

An added cost saving consideration was that all the work could be done by

the plant's own maintenance engineering staff with in-field technical support provided by ENECON's Engineering Team.

Each elbow required just \$1,000 worth of CeramAlloy materials which represented an extraordinary cost saving over traditional repair and / or replacement procedures being considered.
