South Florida Municipality Salvages “Hopeless” Pump Impeller with DurAlloy & CeramAlloy for Less Than Half of What a New Impeller Would Have Cost.

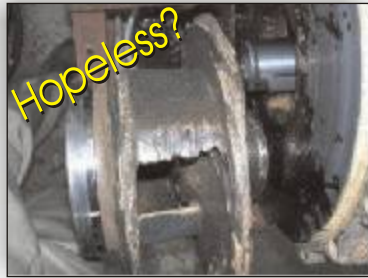
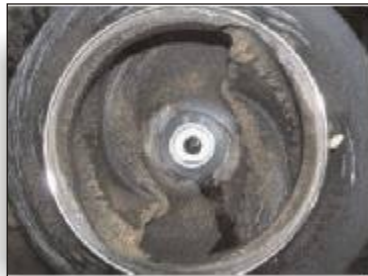
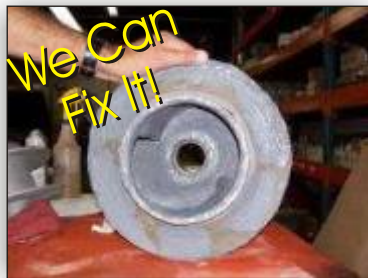
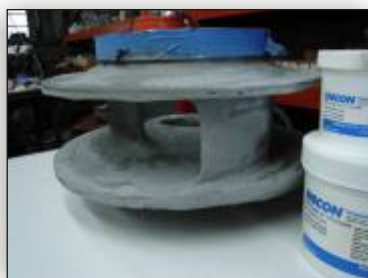
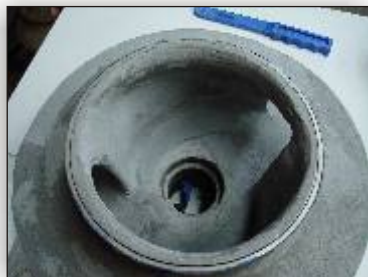
A municipal wastewater treatment plant in South Florida realized they had a problem with one of their pumps. These pumps work all day pumping “sewage, grease, sand, rocks, you name it,” according to the plant engineers. Because of the harsh environment the impellers on these pumps take a severe beating.

When they inspected one of these badly damaged impellers, the plant engineers thought that a repair was “hopeless”. But the local ENECON Fluid Flow Systems Specialist said, “Not so fast.” “We can fix it!”

The original size of the impeller was 295 millimeters. The damaged impeller was only 281 millimeters! Not only was the impeller very worn, but

the top and bottom flanges were out of round and uneven, as well. Because of its machinability, DurAlloy was first used to rebuild all the damaged areas back to original shape and contour.

Two coats of CeramAlloy CL+AC were then applied to completely resurface and protect the impeller and improve the pump’s overall efficiency.

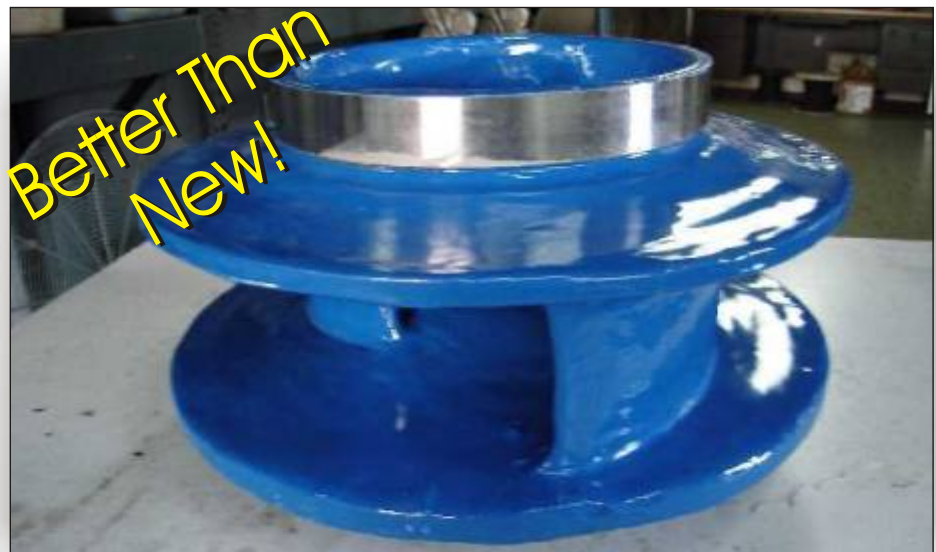
Better Than New!
