CHEMCLAD & ENESEAL Save Large Water Tank at Chilean Dairy Product Manufacturer

Client:
Dairy Product Manufacturer

Location:
Chile

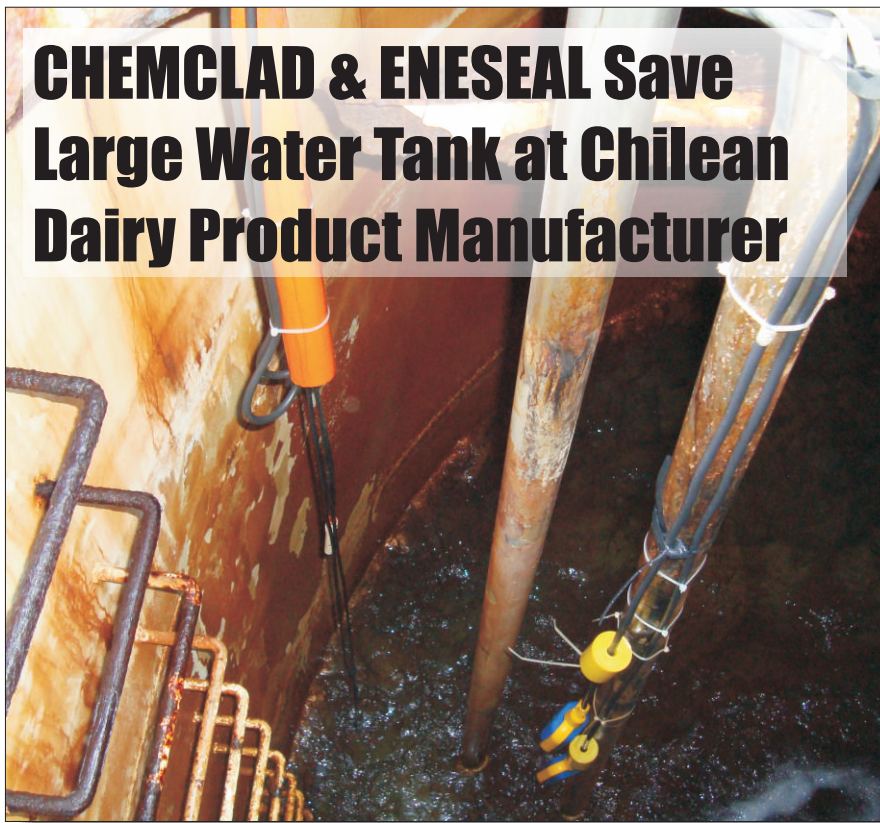
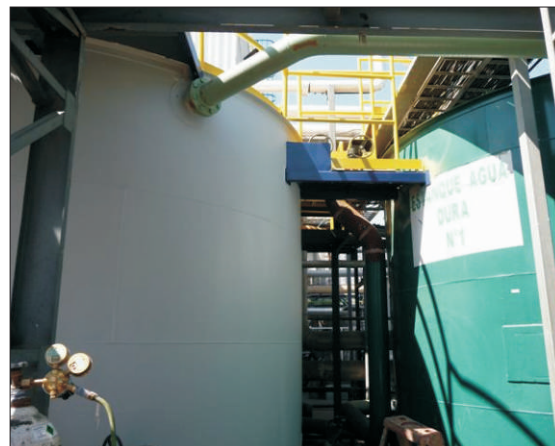
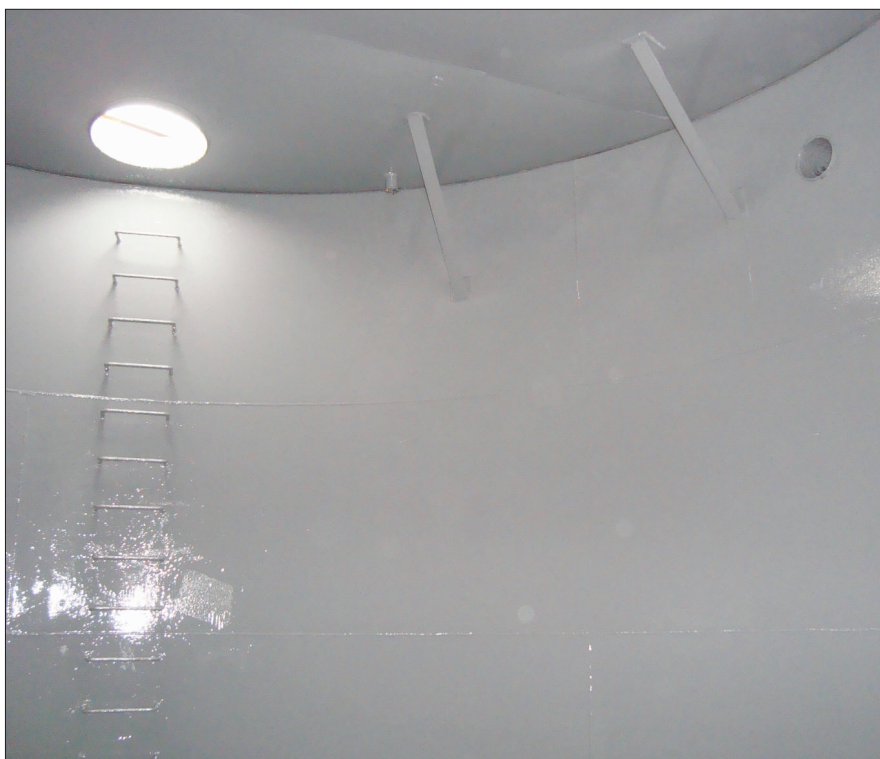
Problem:
Large hard water tank suffering from interior and exterior corrosion.

Solution:
The interior of the tank was grit blasted to a white metal finish then protected with 2 coats of CHEMCLAD SC. After mechanically cleaning and power washing, the exterior of the tank was protected with 2 coats of ENESEAL CR.
