## Ash Slurry Pump Impellers Rebuilt & Resurfaced With CeramAlloy

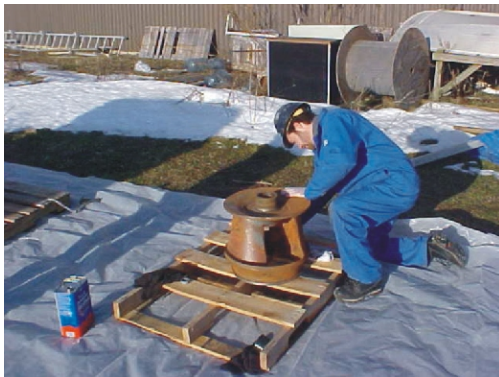
Impellers placed on pallets outdoors and then grit blasted to minimum 3 mil profile.

Both impellers were grit blasted and the eroded areas were rebuilt with CeramAlloy CP + AC. Two coats of CeramAlloy CL + AC were then applied to completely resurface the impellers and protect them from future attack.

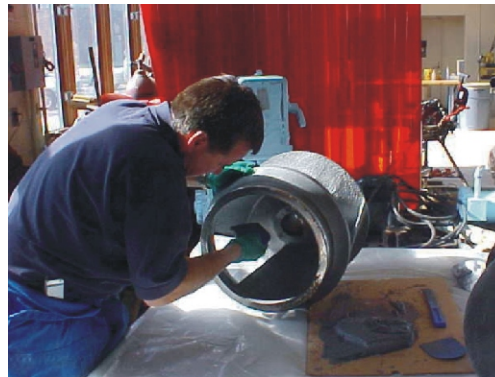
CeramAlloy CP + AC was used to smooth out and rebuild eroded areas of both impellers.

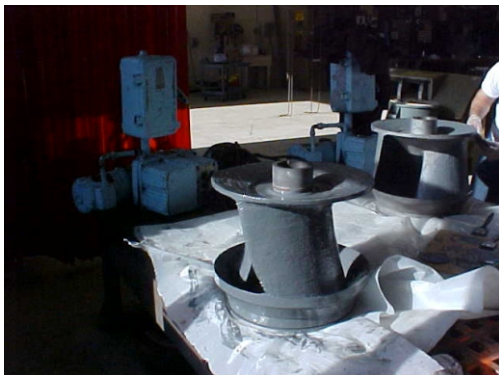
CeramAlloy CL + AC was used to treat any areas not covered by CP + AC

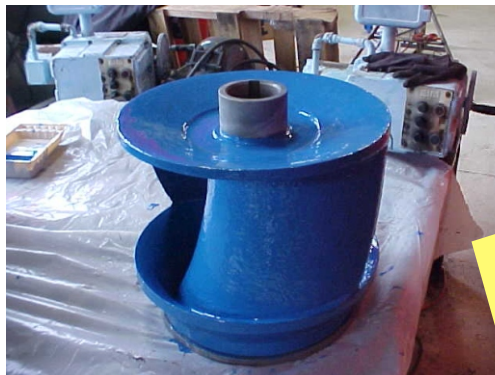
Finished impeller after second coat of CeramAlloy CL + AC

**Both impellers were  
reconditioned for less  
than half of what new  
impellers were going  
to cost.**
